# Perspectives

*Paul Marquis*

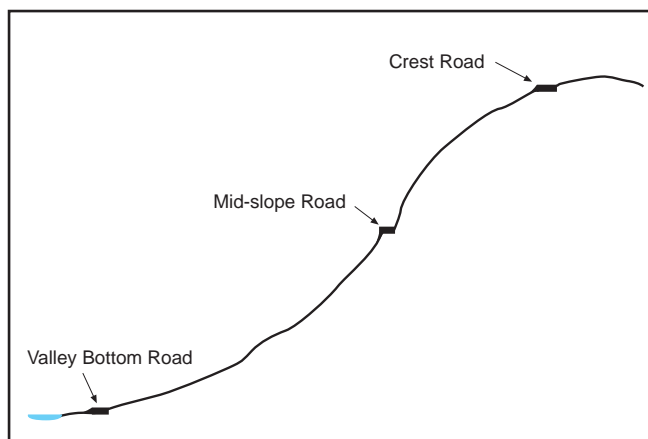
The first problem is that the original prescription was not always appropriate. In other words, was the decision to locate a cross ditch at a specific location the correct one? During my field inspections I have encountered many cross ditches which contain very little or no water even after a prolonged precipitation event. A significant amount of money could have been saved if these structures were never constructed.

Figure 1. In most cases, the small area up-slope of the crest road will not produce a significant volume of runoff.

cases will simply percolate into the groundwater system just as it would have done before the road was constructed. In areas where there are no stability concerns, a cross ditch is only appropriate if the potential runoff volume is such that it will cause excessive erosion to either the ditch line or the road surface.

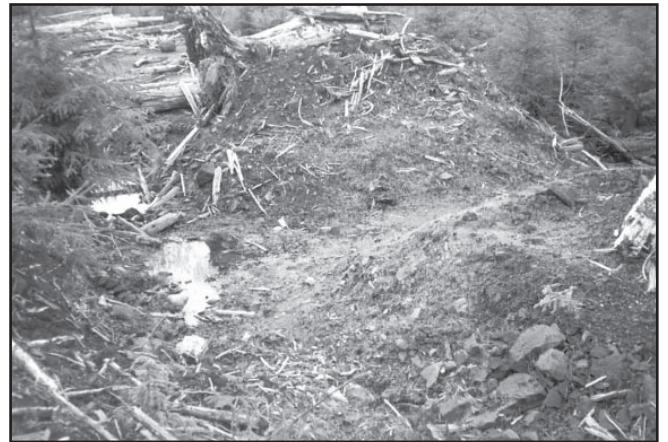
Another common problem with cross ditches is that water tends to pond within the cross ditch (see Figure 2) when the gradient is too shallow (i.e., the slope of the channel is insufficient between the invert at the ditchline and the outlet on the down-slope side of the road). In areas with unstable sideslopes this problem can increase the pore pressure within the soil matrix which, in turn, increases the likelihood of a mass wasting event.

Figure 2. When a cross ditch has an inward slope, as shown here, the water cannot drain from the ditch.

Most road deactivation publications suggest that a cross ditch should be out-sloped between 2 to 3% to prevent sediment from building up within the structure (Wong 1997). This recommendation applies only to roads for which vehicle access is to be maintained. For cross ditches that are to be constructed to the “no vehicle access” (i.e., T4) standard, the out-slope gradient should be greater than 3%. Unfortunately, it is almost impossible for an excavator operator to estimate slopes to within one degree (1 degree = 2.2%) and unless there is water flowing through the cross ditch at the time of construction, its gradient is easily misjudged. For roads where vehicle access is to be maintained, the gradient on a cross ditch should be maximized while still allowing for vehicle passage (i.e., a gradient of at least 5%). On roads designated for no vehicle access, the cross ditch gradient should match the natural angle of the slope.

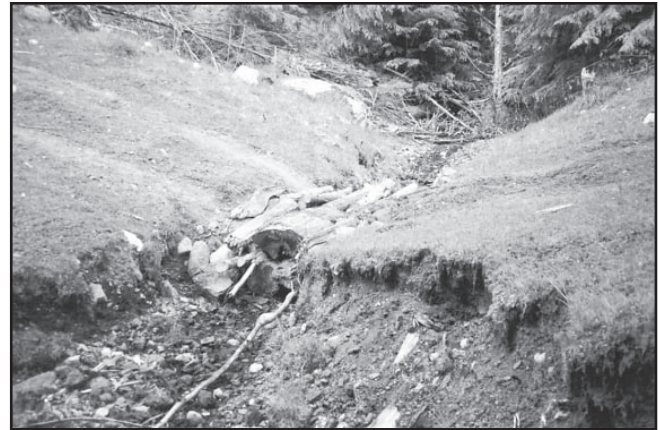
Figure 3. This stream restoration should have allowed for vehicle access, but the lack of adequate armouring resulted in the down-cutting of the stream channel. To regain access, a salvage crew has placed logs into the structure. Note, also, that the vehicles have scraped off the protective layer of grass on both approaches, which will further exacerbate the sediment problem.

Proper armouring of water control structures will increase the cost of the deactivation. Specifically, there will be additional excavator time required to sort and place the rock. In addition, where there is no suitable armouring material on site it will have to be developed and imported from another location. Despite this extra expense, it is preferable to do the job correctly the first time rather than to risk additional environmental damage as well as to incur the often greater costs associated with remedial work.
