Stream Restoration and Slope Stabilization of a Ravine Landslide

B. Sander, J. Summers, M. Bradshaw, and T. Watson

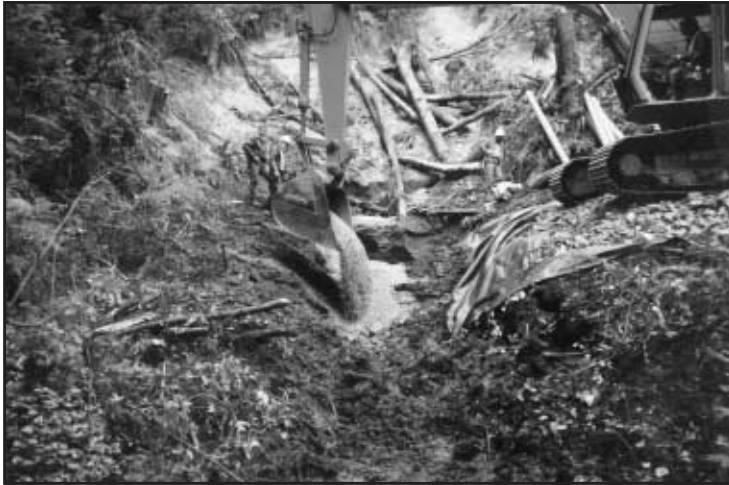
Figure 2. Slope failure in Kendale Creek ravine, North Delta, BC.

The slope failure deposited bank materials into the creek channel adjacent to the failure zone, damaging the fish habitat. The creek subsequently eroded a narrow channel through the fine, deposited materials. There may have been some velocity barriers created by focused flows in the narrow channel, causing further damages to habitat. The deposited materials were a source of sediment; these materials were transported downstream during higher flow events. Downstream deposition further limited fish habitat by partially infilling the pools.

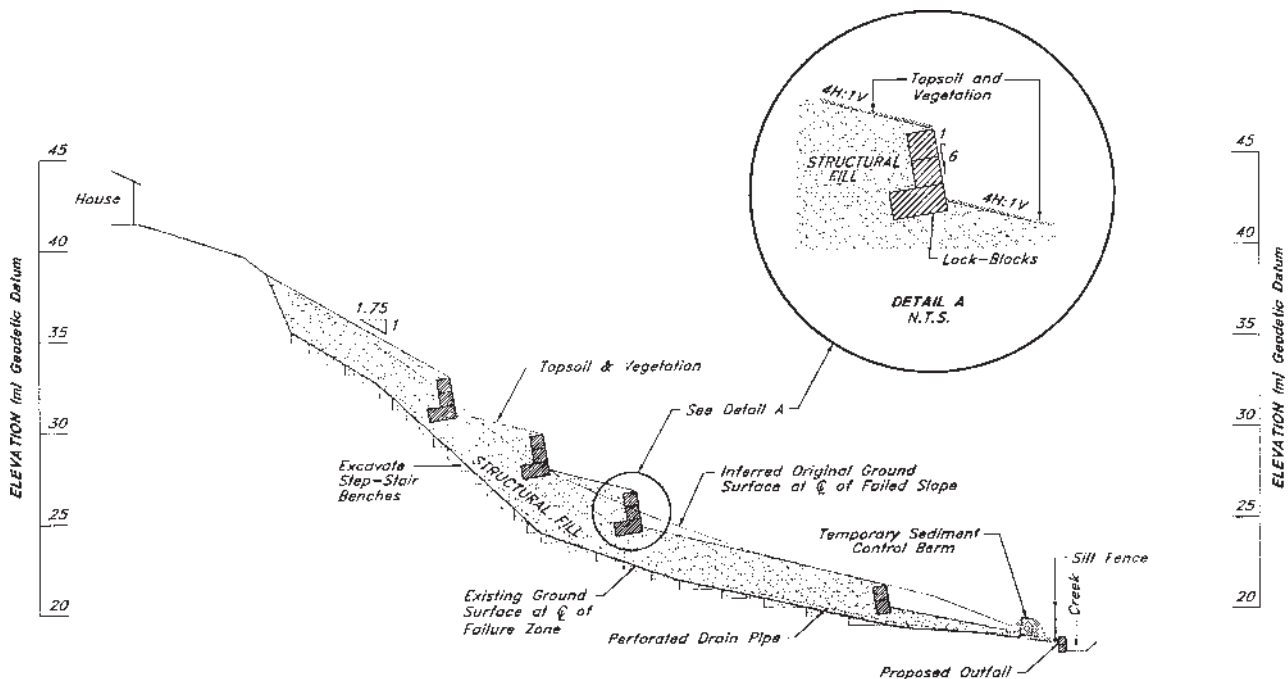
Figure 3. Slope stabilization measures.

Option 4 was eventually selected due to the speed with which construction could be undertaken, cost considerations, and the ease with which this system could be adapted and modified on site to suit the challenging site conditions.

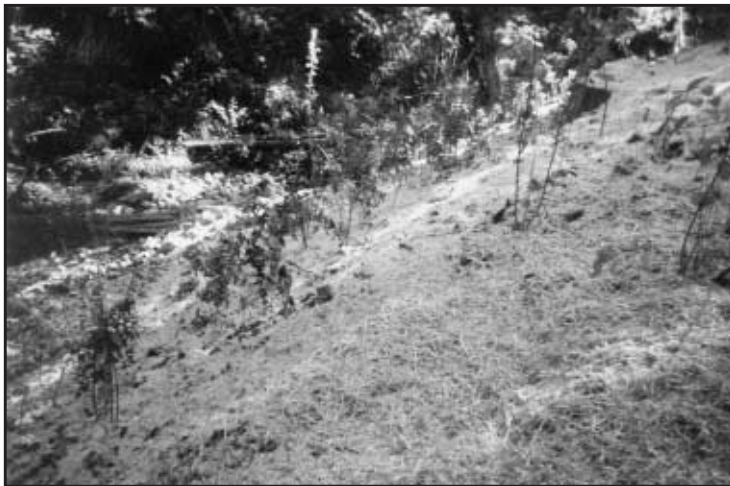
Figure 4. Base of rehabilitated slope, vegetation and Sediment-Lok™. Background shows restabilized stream channel.

reason, the original topsoil was scalped and stockpiled, and rootwads, small woody debris and rotten logs were saved. Upon completion of the stabilization works, the road ballast was removed, and the original topsoil was spread and seeded where the road had been only the day before. To permanently stabilize portions of the ravine slope, some Lock-blocks remaining from the road edge were left in place and buried. Stockpiling the topsoil was not only cost-effective, but gave reclamation a head start by providing a rich, native seed bank. Throughout the site, exposed soil was hydro-seeded to stabilize the surface and to prevent erosion. TERRASOL's Sediment-Lok™ was used to stabilize the soil within the failure area, and was found to be an effective erosion control and reclamation tool (Figure 4). No rivulet formation was noted, and dense, widespread germination was seen within the first week following application. The edges of topsoil were lined with a silt fence at the project outset, and will remain in place until the next growing season is complete.

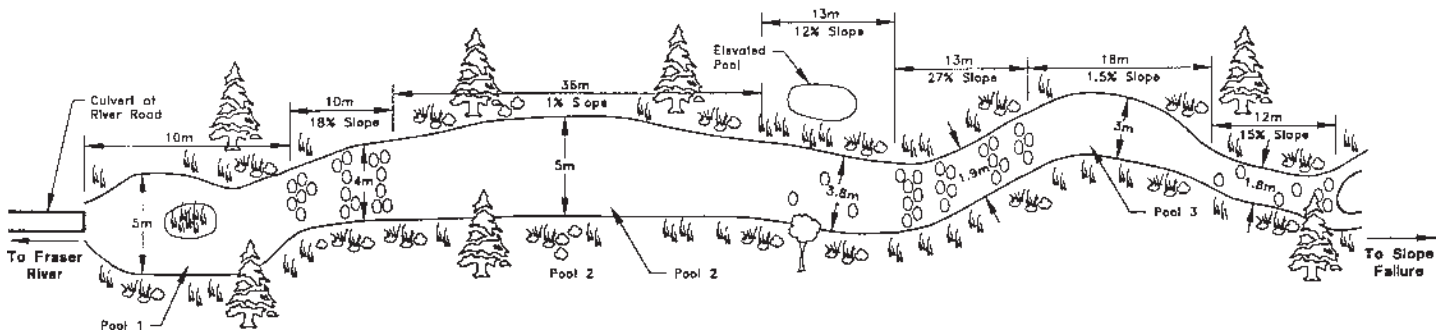
Figure 5a. Kendale Creek prior to rehabilitation. This section of the creek runs from the culvert at River road 112 m upstream towards the slope failure (not drawn to scale).

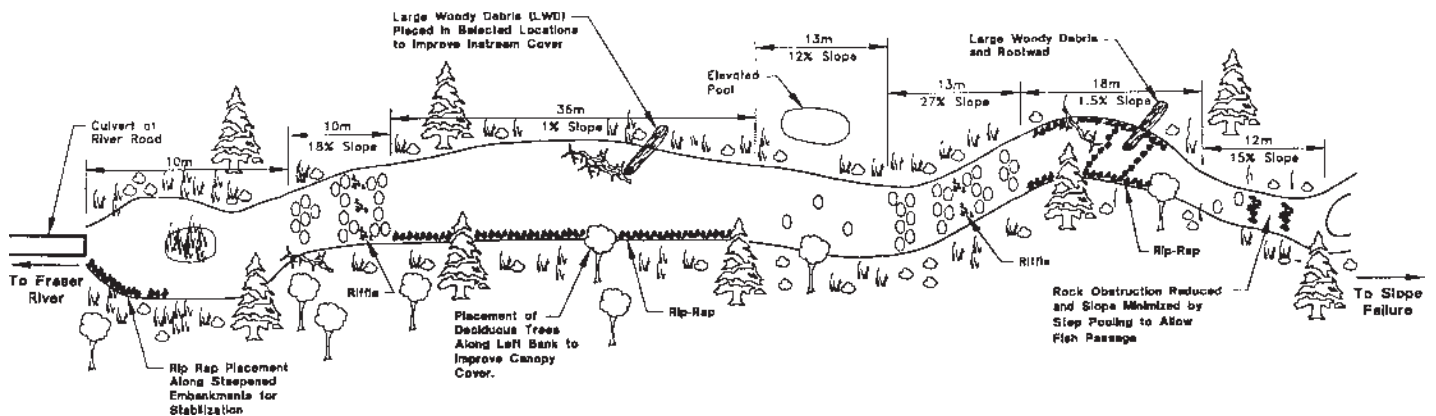
Figure 5b. Rehabilitation of Kendale Creek included the addition of rootwads and rip rap in 3 pools, constructions of a step-pool to allow fish passage at the obstruction and planting of riparian vegetation (not drawn to scale).

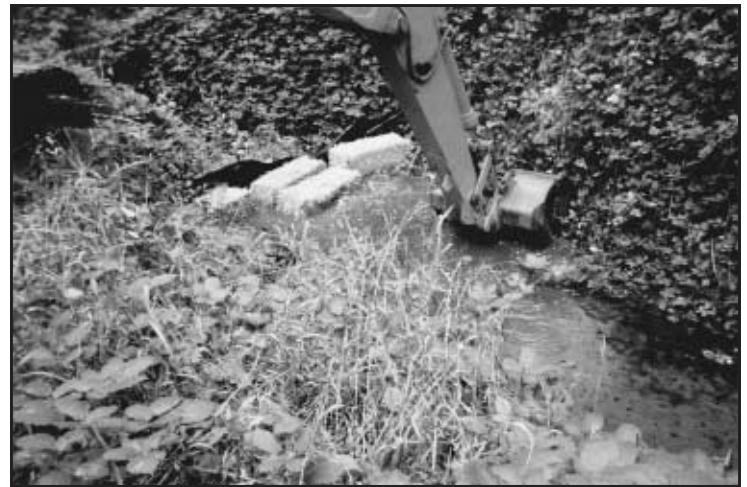
Figure 7. Restoration of Pool 3 showing placement of rip rap to stabilize undercut banks and of LWD to increase rearing habitat.
