A Discussion of Fish Passage at Culverts in the Cariboo Region, British Columbia

Michael Parker

Cottonwood Culverts Post-Flood Assessment August 1999

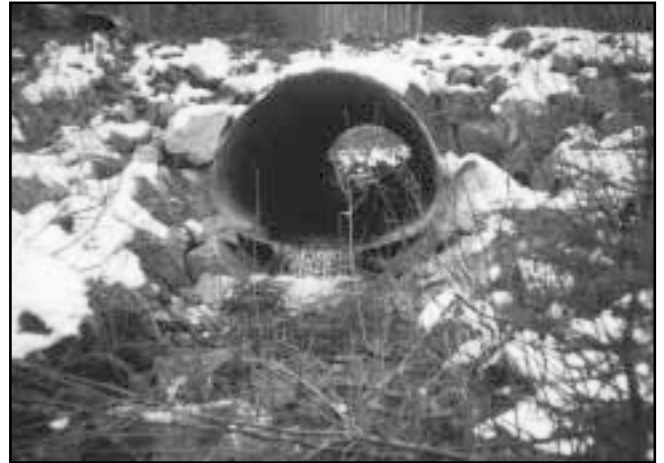
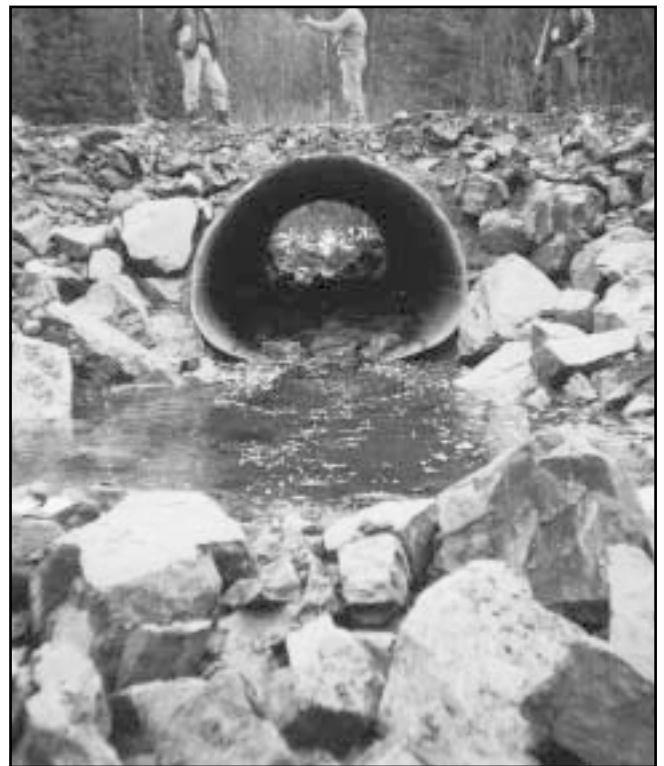
Figure 3. Before and after pictures of a culvert crossing on the a tributary to the Cottonwood River, near Quesnel B.C., for which a weir was constructed to backflood the culverts to provide fish passage.
