Evaluating the Performance of Channel and Fish Habitat Restoration Projects in British Columbia's Watershed Restoration Program

Andrew Wilson, Pat Slaney and Heather Deal

In 2000 and 2001, a performance evaluation was undertaken on a subset of aquatic Watershed Restoration Program projects completed between 1995 and 2000. The objectives of the evaluation were to:

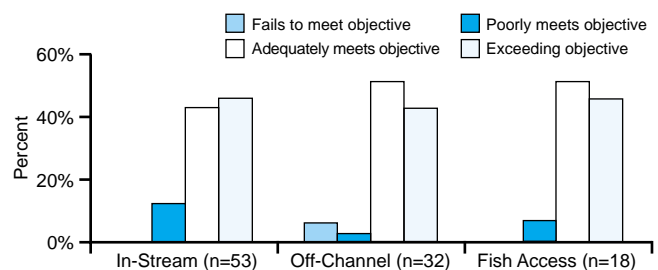
Overall, the results of the performance evaluation indicate that the Watershed Restoration Program has been very successful (Figure 1) at achieving site-level restoration objectives. Fish access restoration had the highest level of success, with 94% of projects evaluated meeting or exceeding objectives as compared with instream (81%) and off-channel (92%) projects. While the success levels were high for all three components evaluated, room for improvement for each was identified.

Figure 1. Overall success of in-stream, off-channel and fish-access restoration projects.

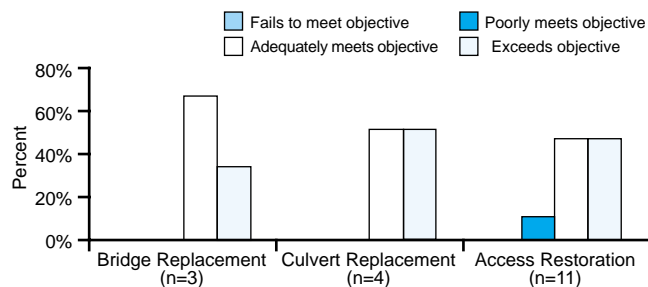
Three types of fish access restoration were evaluated: bridge replacement (3), culvert replacement (4), and access modification (11). Regardless of the type of fish access work, restoration success was high (Figure 2). The only project type that showed shortcomings was fish access modification. Factors affecting restoration success of fish access modification projects included use of undersized boulder material along outlet weirs and insufficient depth in outlet pools to facilitate fish passage.

Figure 2. Overall performance of fish access modification projects broken out by type.

Because of the overall high level of success with fish access modification projects, few lessons can be learned that will improve delivery. The high level of success and extent of habitat made available for target fish species make this restoration component a very valuable tool for addressing aquatic sustainability issues. Further studies such as that of Parker (1999) examine the most appropriate method of constructing outlet weirs to aid in overcoming any potential shortfalls associated with fish access modification projects.

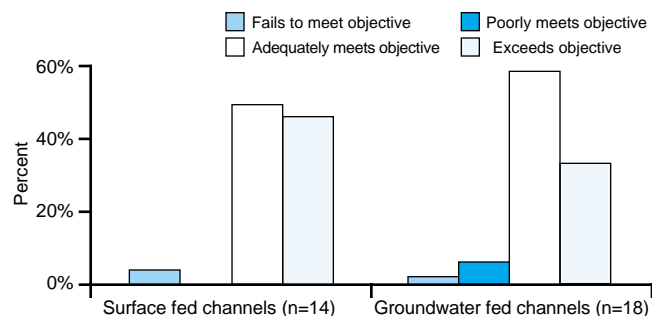
The off-channel performance evaluation considered both surface-fed (14) and groundwater fed (18) off-channel projects. As with fish access restoration, overall success was very high regardless of off-channel type (Figure 3). However, project failures were identified in both categories.

Figure 3. Overall success of side-channel projects broken out by channel type.

Failures associated with off-channel projects were either a result of intake problems (in the case of surface-fed channels), channel dewatering or channel isolation. Due to the nature of operation, surface-fed channels require routine maintenance to ensure debris does not foul intakes, and to excavate settling ponds or other sediment traps. In one occasion this routine maintenance was insufficient to prevent failure of the channel intake, leading to erosion and project failure. In other cases, large-scale flood events isolated side-channels as the mainstem river channel degraded.

Routine maintenance will continue to be an issue with side-channel projects. A lesson to be learned from this component of the performance evaluation is that long-term funding must be identified and secured to provide annual monitoring and periodic routine maintenance of these projects. Considerable investment has been made across the province to construct stable side-channel habitat, and the contribution they make to overall smolt output in salmon streams has been documented repeatedly (e.g. Cleary 2001, Decker and Foy 1998). This benefit far outweighs the cost of an annual inspection and maintenance program and must be acted on by government in combination with stakeholder groups active in watershed restoration and protection.

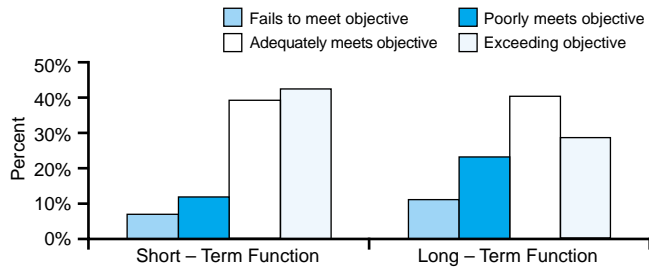
When considered at the project level, instream restoration was found to be highly successful, with no projects failing to address restoration objectives and only 13% poorly addressing objectives (Figure 1). However when considered at the site level, the results indicate that across all projects, 19% of sites poorly met or failed to meet objectives over the short-term (5-year) and this increased to 32% when performance was projected over a longer (20-year) period (Figure 4).

Figure 4. Function of in-stream structures over short (5-year) and long (20-year) time frames (n=552).

The decreased performance of instream restoration structures over longer time periods is a cause for concern for watershed restoration planners and practitioners. Instream restoration structures are installed with the objective that they will provide habitat or channel structure benefits for at least a 20-year period (Slaney and Martin 1997) following installation. However, this target is not being met given the results of this performance evaluation.

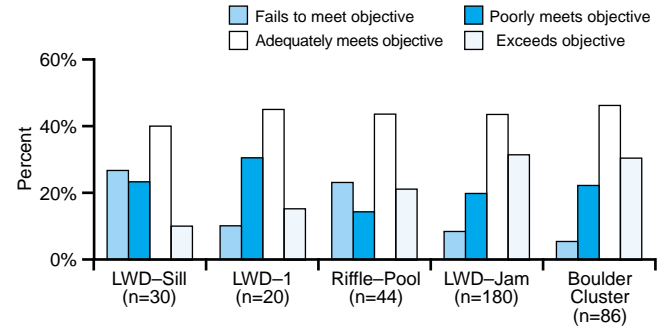
Instream structure performance was found to vary by structure type. Habitat structures that tended to have a higher percentage of success included boulder clusters and lateral large woody debris jams. Structures that tended to have lower success included sill logs and pool-riffle reconstruction (Figure 5). Full channel spanning structures tended to perform less well than either laterally placed structures or structures placed in the channel as observed in the USDA Forest Service studies (Figure 6). This finding was partly due to the improper placement of full spanning structures or installation in watersheds or reaches with unfavourable

geomorphic conditions (e.g. unconsolidated streambanks). Issues with riffle-pool reconstruction included in-filling of pools with bedload sediment, outflanking and displacement of riffle crests.

Figure 5. Long-term (20-year) function of in-stream, restoration projects broken out by structure type.

5. Caution must be used when selecting channel-spanning structures for instream restoration. Geomorphic and hydrologic factors in watersheds, reaches and sites must be taken into consideration when planning to use these types of restoration structures. Although these types of stream features may be prevalent in old-growth templates, they are likely transitory in nature and as such are not the best option for providing habitat over a 20-year period.

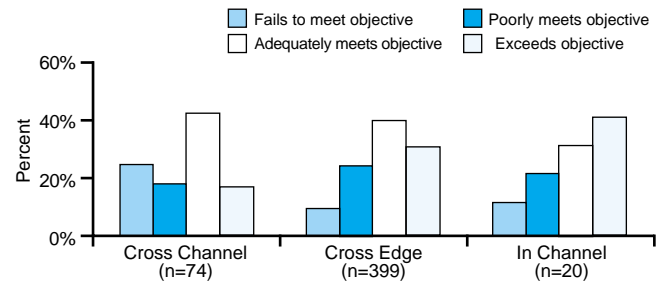
Figure 6. Long-term (20-year) function of in-stream, restoration projects broken out by channel placement.

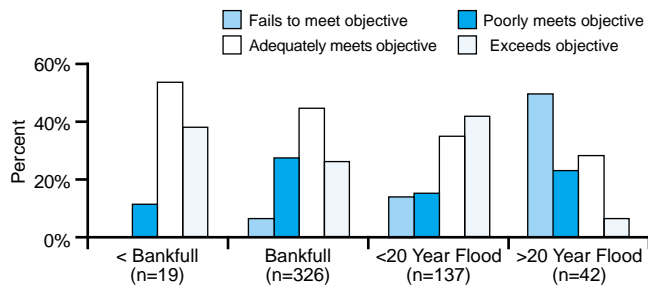
Post-construction flood history greatly influenced structure performance. The majority of watersheds that the Watershed Restoration Program has been actively involved with have not been subjected to large-scale (e.g. greater than 20-year return period) post-construction floods. In those incidences where very large magnitude floods have occurred, structure performance was observed to be poor (Figure 7). This finding parallels that of studies conducted throughout the Pacific Northwest following regional flooding in the mid-1990s (Roper et al. 1998). While the percentage of structures failing to achieve site objectives was high for those watersheds experiencing a greater than 20 year return interval flood event, it should be cautioned that this is based largely on the results of a single project in Martin Creek. In this one instance, the 50-year flood design capacity of the project was exceeded during a 100-year return interval flood that occurred in the summer of 2001 in isolated areas throughout the north east corner of the province.

Figure 7. Long-term (20-year) function of in-stream, restoration projects broken out by post-construction flood history.

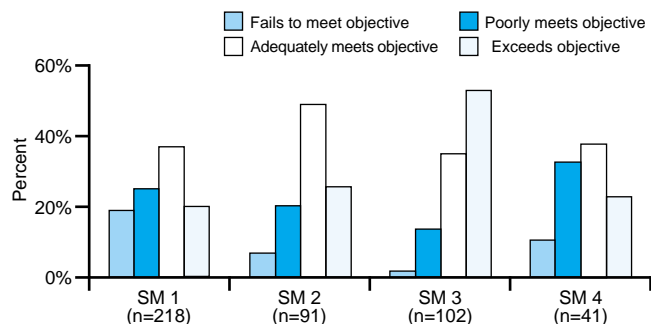
structure performance decreased with increasing stream order or magnitude (e.g. Roper et al. 1998). However, this study identified a modal or humped distribution, with a higher percentage of structures meeting or exceeding performance objectives in the medium sized watersheds (Figure 8). The lower success in small magnitude streams probably reflects the difficulty of undertaking instream restoration in steeper headwater streams or small channels located on alluvial fans.

Figure 8. Long-term (20-year) function of in-stream, restoration projects broken out by stream magnitude (SM1=1-20, SM2=21-40, SM3=41-100, SM4>100).

6. Avoid pursuing instream restoration in steep headwater streams and on alluvial fans. Where restoration is a requirement to achieve sustainability and restoration objectives, consider watershed processes and take into account the dynamic nature of the surroundings.
