# Fish Creek Revisited: Restoring a Whole Watershed

Tracii Hickman and Dan Shively

Seven years have passed since an article on the Fish Creek Watershed was published in *Streamline* (Vol. 1, Issue 1). This article updates hillslope and instream restoration activities initiated since the winter floods of 1995–1996, and presents preliminary results of post-flood restoration monitoring, along with lessons learned from a watershed-wide restoration project.

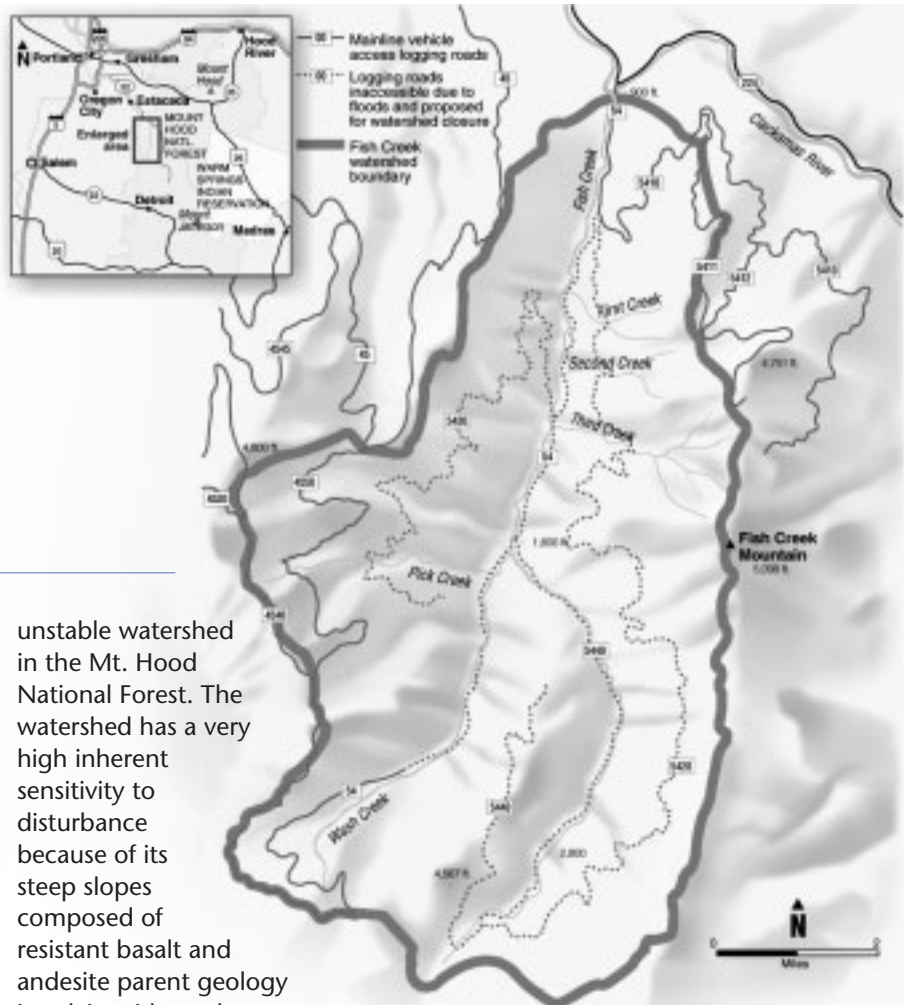
*Paved roads decommissioned. Not shown are gravel and native surface roads also decommissioned.*

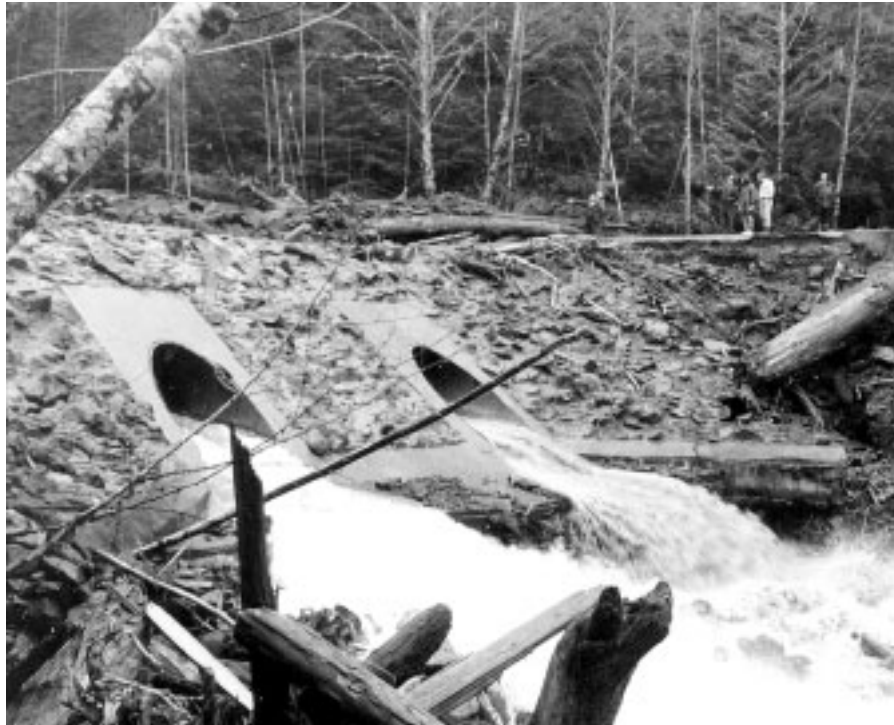
Third Creek crossing on road 5420 immediately after the 1996 flood.

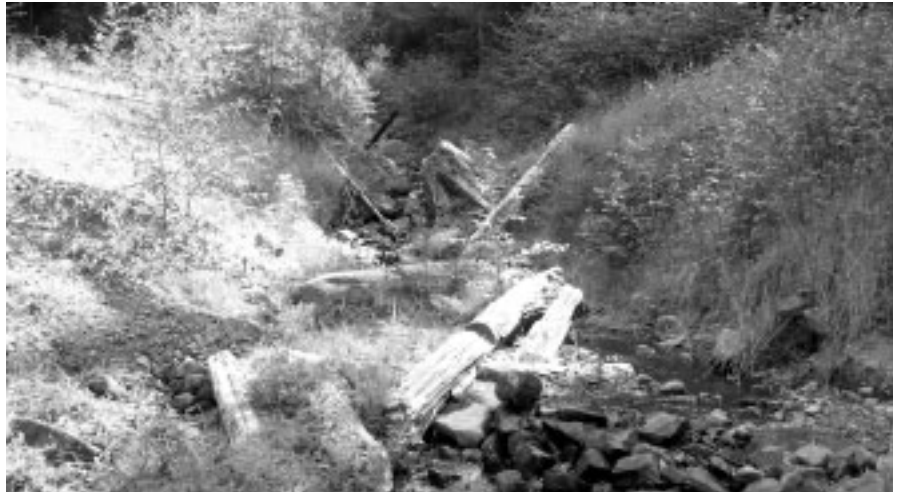
*Third Creek crossing three years after culvert removal and road decommissioning.*
