Watershed Restoration Technical Bulletin

Streamline

Vol. 5 No. 4

Increased Abundance of Rainbow Trout in Response to Large Woody Debris Rehabilitation at the West Kettle River

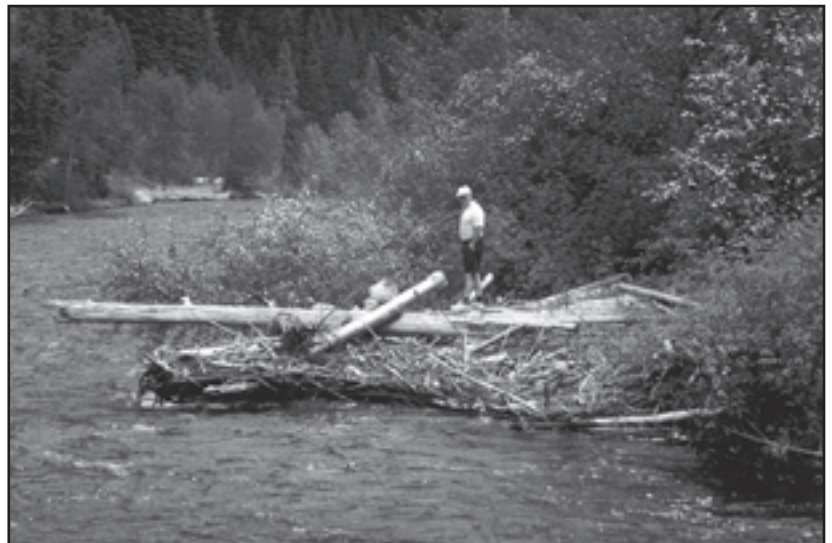
Figure 1. An example of a natural lateral log-jam at the West Kettle River. This river section was logged to its banks in the past, and it was used as a control in evaluating effectiveness of fish habitat rehabilitation.

The rehabilitated section is located halfway between Westbridge and Beaverdell on Highway 33, and it is bordered largely by Crown forest lands. In this alluvial reach, infrequent mainstem pools are typically associated with log jams. The alluvial demonstration section is 2.5 km in length and has a wide floodplain. The main test section is 2.0 km in length, 0.4 % in gradient with riffles about 1%. Bankfull channel width is 36 m, and the riverbed is dominated by cobble with sub-dominant gravels. The banks are dominated by sandy gravels and cobbles are secondary. Channel widening is evident in some subsections of the reach. The river transports significant quantities of large wood, but there are infrequent jam initiators in the alluvial reaches, which were largely logged to their banks on both public and private lands (Figure 1).

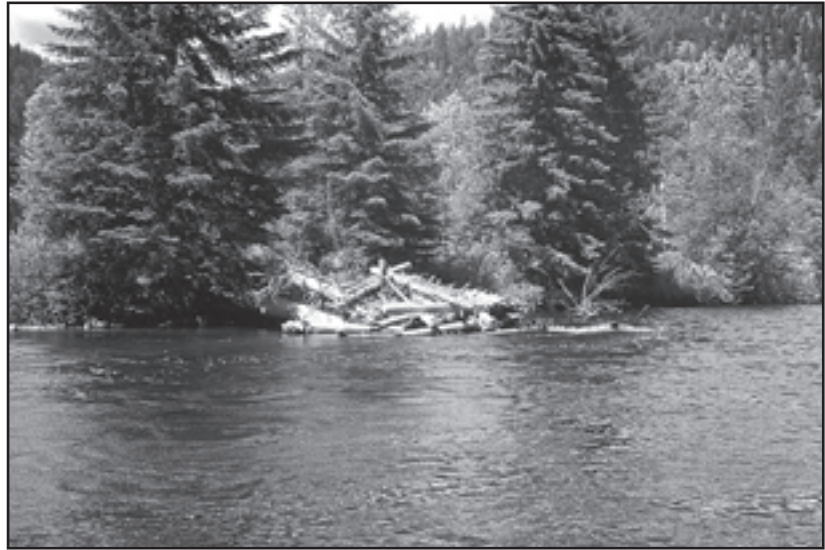
Figure 2. A lateral log-jam formed during the flood (25 yr.) of 1997 at a "debris catcher" structure. It scoured a > 2 m deep pool, well-utilized by adult trout and whitefish.

In 1990, experimental pool-forming structures were first installed in an alluvial reach of the West Kettle River. This was accomplished by driving 3 m rails level with the substrate to function as anchors for chained v-log debris catchers. Because the fixed debris catchers pilot-tested at the Nechako River had protruding rails that did not emulate natural features, floating v-logs were employed. However, porpoise-like action of the floating v-logs at flood stages largely prevented these structures from collecting sufficient debris to scour pools. This caused some connections to fail. In 1996, however, one of these floating v-log structures was re-connected to the shore with a large log. This structure then collected substantial woody debris during the large spring flood of 1997, and a large scour pool with abundant cover was established (Figure 2). This indicated that it would be possible to emulate natural lateral jams. Therefore, in 1997, a

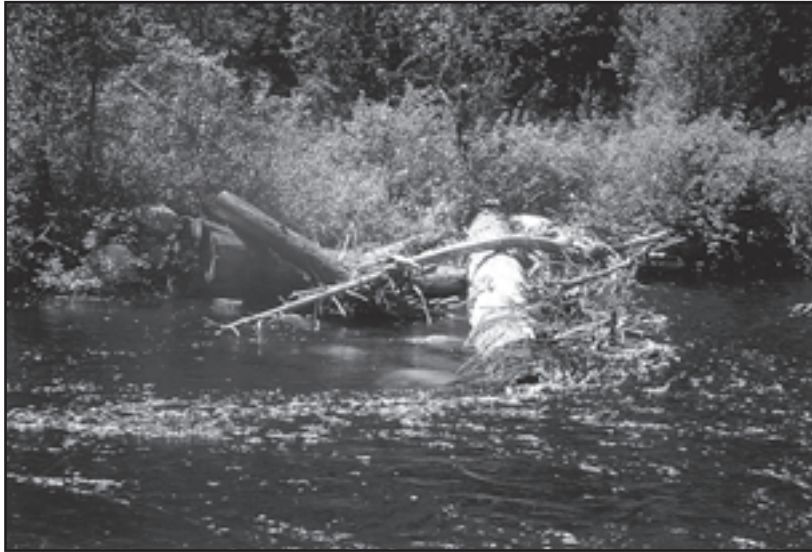
Figure 3. An example of a lateral triangular structure designed to collect driftwood and scour pool habitat for rainbow trout and mountain whitefish in the West Kettle River.

In addition, seven triangular 3-log structures were placed at banks in geomorphic settings where primary or secondary pools or runs would form if large wood accumulated as lateral jams. The design was similar to that in Millar (1997), but three of the seven were modified slightly to improve LWD collection (Figure 3). Three large Interior hemlock (0.5-0.7 m diameter and 15 m in length) were used as structural members. Ballasting was based on the design charts in Slaney et al. (1997; Fig 9-12). Sufficient rounded boulders were used as ballast to achieve a safety factor of about 2 to account for expected loading with drifting LWD; 1 m³ of boulders was used per log in the channel, where fixed attachments were available on the bank. In this design, the lateral structural stability provided by the triangular construction resists the horizontal drag forces; thus, only enough ballast is needed to offset log buoyancy during bankfull flows.

The cable-epoxy method was used to secure logs to boulders in the river channel, using 1.25 cm diameter galvanized steel core cable (Slaney et al. 1997). A minimum of two cable connections per ballast boulder was used, and care was taken to improve aesthetics by drilling holes through the outer edges of logs to hide cables (Figure 3). Cable attachments on shore were either boulders, "deadhead" logs buried in the water table, or tree bases. Instream boulders ranged in diameter from an estimated 0.4 to 0.9 m³, and typically 2-3 boulders per log, or 6-8 per structure, were used to

maximize synergy of LWD and boulders in providing prime habitat features for juvenile and adult rainbow trout. This design is similar to the debris catcher, in that it should also catch drifting LWD, thus creating a lateral jam with a scour pool and emulating the natural process of LWD-structuring of forested channels.

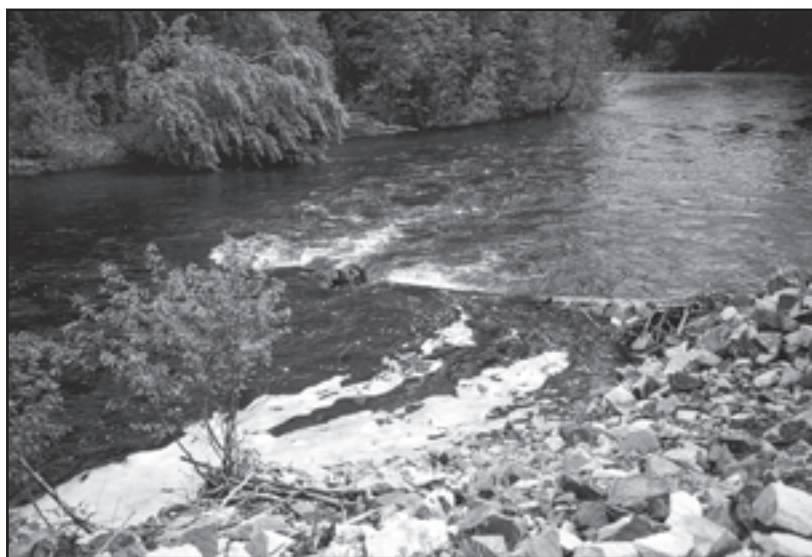
Figure 4. An example of a box groin designed to maintain pool habitat for trout and whitefish at a logged section of the West Kettle River.

In 1998, four additional structures were placed in the section, adapted from a “box groin” design used in smaller streams in Europe as described in Donat (1995; Figure 4). Four parallel logs were placed in a ramp configuration so that the logs faced upstream and also sloped into the streambed (to prevent bank scour). At peak flows, the spilling of water over the logs was designed to maintain a

scour pool, with overhead cover provided by the logs. Similar boulder ballasting (1 m^3 per log) and cable attachments were used to overcome buoyancy, except at the most upstream structure, which was buried to a depth of 1 m with a mixture of sand and rock. These structures were not designed to trap drifting debris (Figure 4). Also in 1998, two sets of three large debris groins were installed on banks of two streambank bends, as described in a previous issue of *Streamline* (Vol. 4, No. 2). These structures, and seven additional structures located upstream of the test reach, have performed as designed. Publication of these results is pending.

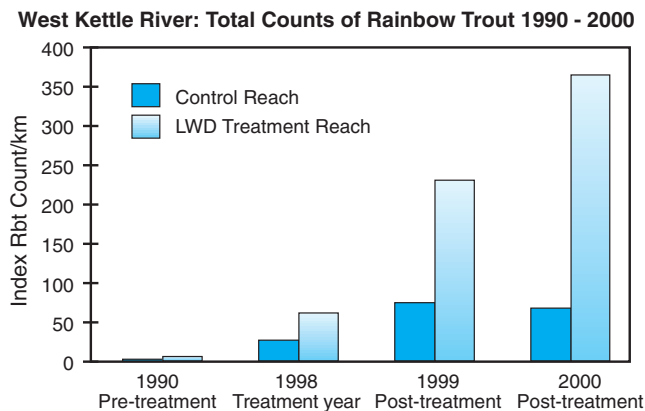
Figure 5. Response of rainbow trout (> 10 cm) to pool-forming large wood structures in 2 km of the West Kettle River.

There was a significant effect of LWD rehabilitation on trout abundance in the treated section compared to the control section ($P < 0.05$). Prior to rehabilitation in 1990, enumeration showed that total numbers of trout > 10 cm in length were extremely low and similar in the two sections: 6 per km in the test reach and 2 per km in the control (Figure 5). In 1998, during treatment, and eight years after a shift to restricted fishing regulations, trout abundance was 62 per km in the LWD-treated reach and 28 per km in the untreated control reach, or a twofold difference. In 1999, when only maintenance was undertaken, numbers increased further, to 232 per km after LWD rehabilitation, versus 75 per km in the untreated reach, or a threefold difference. By 2000, numbers increased further to 366 per km in the rehabilitated reach whereas numbers of trout in the control was estimated at 68 per km, a difference of more than five times (Figure 5). In the treated reach, 70% of trout were closely associated with the structures, and 26% (96/km) were of catchable size (> 20 cm). However, only 3% (12) were > 30 cm, which probably reflects the short time frame, the

gradual deepening of the pools, and perhaps angler pressure. The marked increase in trout abundance after treatment was associated with pool formation at the structures (mean pool depth 1.6 m). Mean numbers of trout > 20 cm per type of structure were 11.3 for the triangular structure, 6.2 for the box groin, and 17.8 for the debris catcher, although sample size was only adequate for the triangular structure.
