Biotechnical Slope Stabilization in Sheep Creek

Pierre Raymond and Dave Putt

In the spring of 1999, a debris slide and earth flow occurred on Sheep Creek Road near Salmo, B.C. The following year, Terra Erosion Control Ltd., in association with Dave Putt of Forterra Consultants Ltd., was retained by the B.C. Ministry of Transportation and Highways (MOTH) to do a field review and recommend biotechnical slope stabilization treatments. Terra Erosion Control implemented the project in May 2001 as a trial for the MOTH. Though the site was challenging for slope stabilization, the work to date has significantly reduced slide and earth flow activity at a cost substantially lower than conventional engineering treatments (e.g., geotextile and rock ballast). This article describes the biotechnical stabilization methods, maintenance, and monitoring work undertaken on site 1 (above the road) and site 2 (below the road, directly above Sheep Creek).

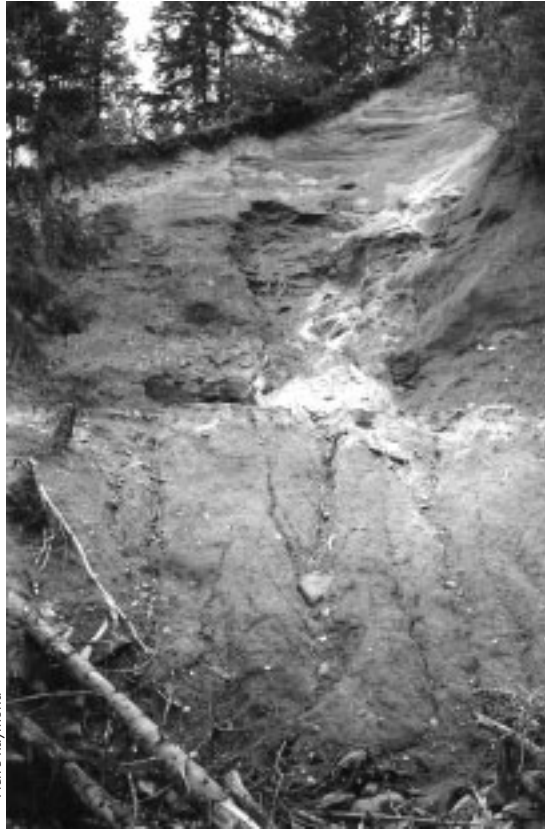
Figure 1. Site 1 prior to project commencement.

flow which failed/flowed onto and over the road (Figure 1). The failure was approximately 30 m wide by 46 m long by a height at the failure headwall of 10 m. Total slide volume was more than 3000 m³. Gradients on the slide headwall ranged from 80 to 150% and from 30 to 60% on the debris at the toe of the slide. The material is primarily interbedded, glaciolacustrine silt and sand with some clay that is overlain by glaciofluvial sand and gravel. The glaciofluvial material is dry, loose, and well to rapidly drained. The underlying glaciolacustrine materials are poorly drained and include extensive areas of seepage. The water table is perched on silt and clay layers at several locations.

Combinations of biotechnical slope stabilization methods were used on both sites to re-establish vegetation and provide stability. On site 1, modified brush layers were installed on the upper section in the glaciofluvial materials. These structures aimed to reduce the raveling of sands and gravels. Contour fascines and drain fascines used in combination with central live pole drains were installed to stabilize the areas with seepage and control excess surface water and seepage on the site.

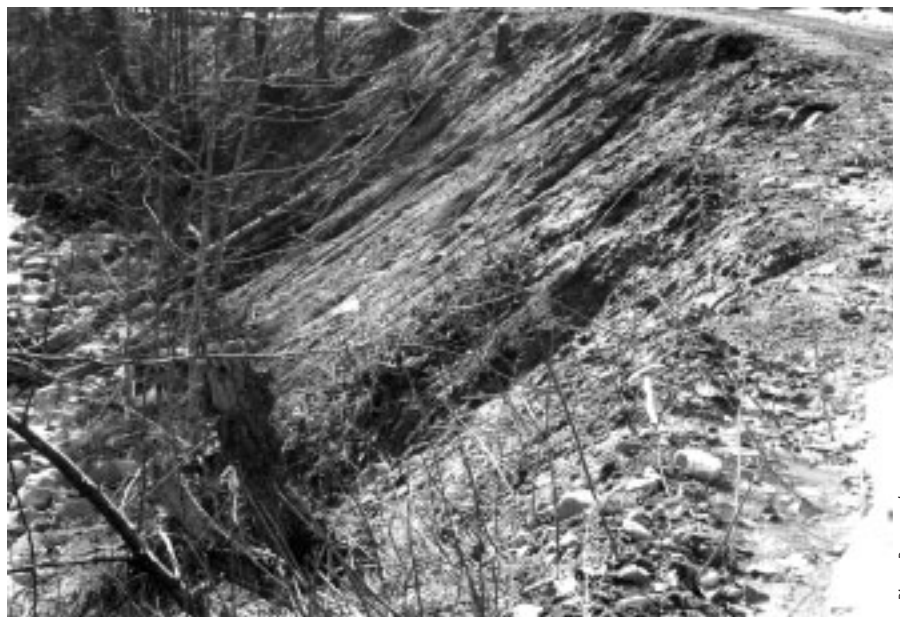
The site below the road (site 2) is a road fill slope (gravel, sand, and silt from site 1) with sidecast directly into Sheep Creek (Figure 2). The failing portion of the fill slope is 31 m long by 10 m wide. The fill slope gradients are 80–100%.

Figure 2. Site 2 prior to project commencement.

Treatment of site 2—the top of the fill slope immediately below the road bed—consisted of a combination of contour fascines with brush layers. This structure helps to keep road sidecast material from raveling and eroding. Modified brush layers were installed in a staggered pattern, between the creek high water mark and the contour fascines/brush layer structure at the top of the bank.

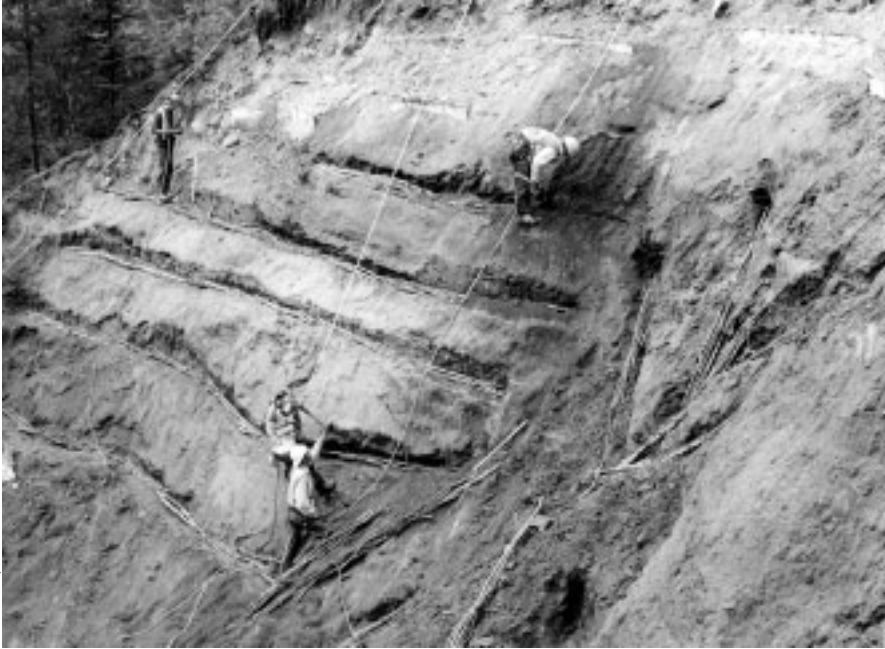
Figure 3. Contour facine installation.

A crew of seven people installed the structures in May 2001 (Figures 3, 4).

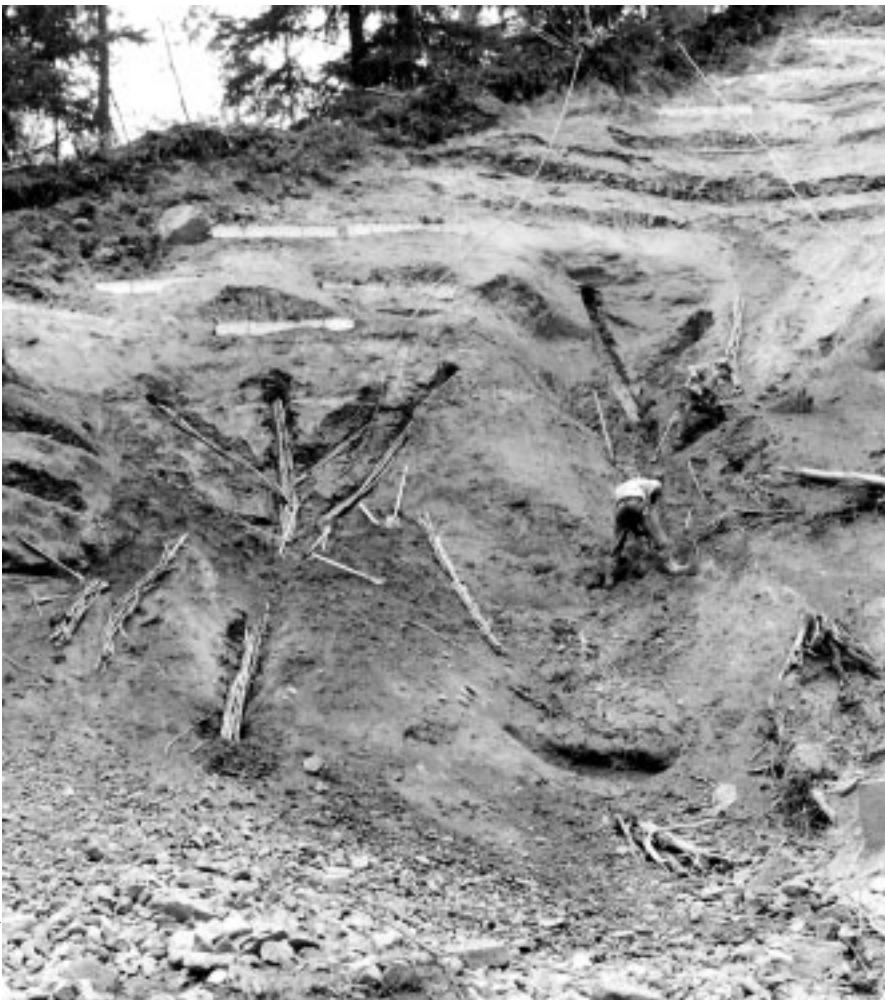
Figure 4. Site 1: Live pole drain installation.

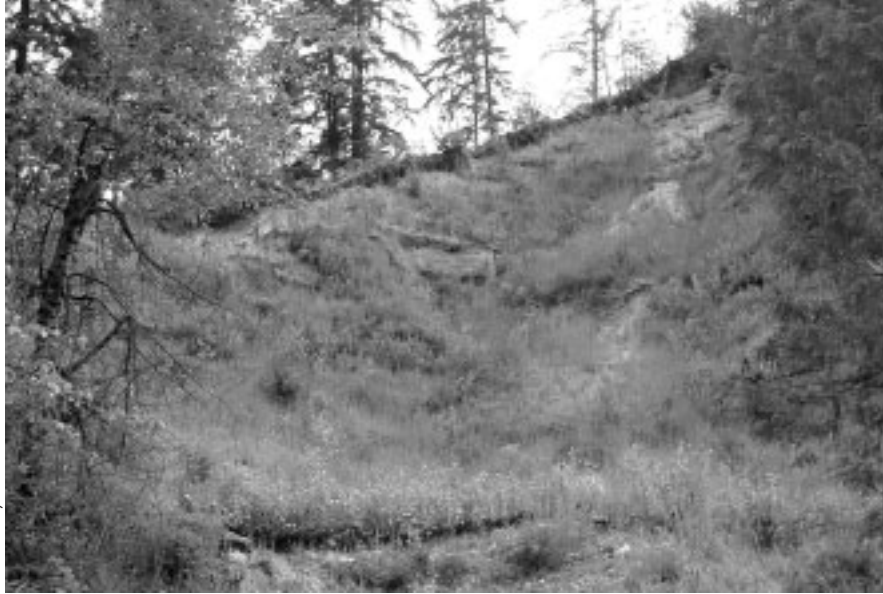
Figure 5. Site 1 post treatment.

Currently, the site is approximately 90% rehabilitated (Figure 5). Some of the very steep slopes (>120%) have again sloughed in spite of the 2002 repair work. Most of the sloughs are not in critical areas and are not significantly contributing to sediment delivery to the creek. In retrospect some of this sloughing could have been prevented if the slope angle had been reduced using machinery. Modified brush layers on both sites 1 and 2 showed dieback of approximately 40% on the drier areas. This may be due to competition from hydroseeded grasses and legumes. Shoot growth on the main structures ranges from 70 to 230 cm for an overall average of 150 cm.

The above treatments have to date significantly reduced slide and earth flow activity in areas where, before the treatment, slides and earth flows occurred both onto the road and fill slope. About 95% of the structures sprouted in the first growing season; overall shoot growth averaged 70 cm, and alder height growth averaged 63 cm. Live pole drains were functioning

very well and remained in place after a heavy snowmelt. A few small failures of <math><200\text{ m}^3</math> occurred from the head and sidewall scarp, causing the collapse of some modified brush layer structures located below them. Overall, approximately 10% of structures failed, a rate within expectations.
