# Elk River 2005 Channel Stabilization Project

## Part II: Monitoring Results

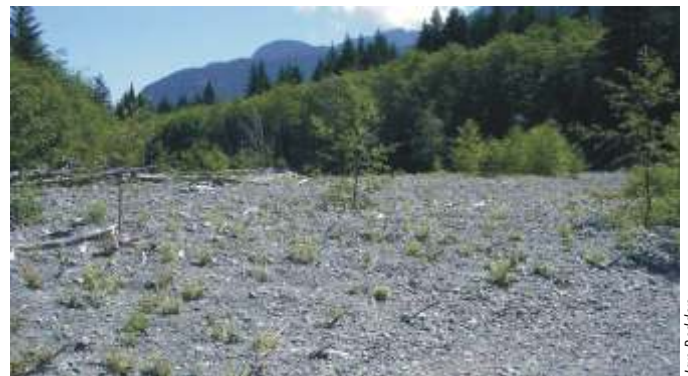
Figure 1. Live-staked area in June 2005, early in the growing season.

rate at 62%. Unfortunately, due to misidentification of several cottonwood stakes as willow stakes in baseline monitoring the cottonwood survival rate could not be calculated. However, observations indicated that the rate was high, and likely on par with the willow survival. A typical area of staked gravel bar early in the growing season is shown in Figure 1.

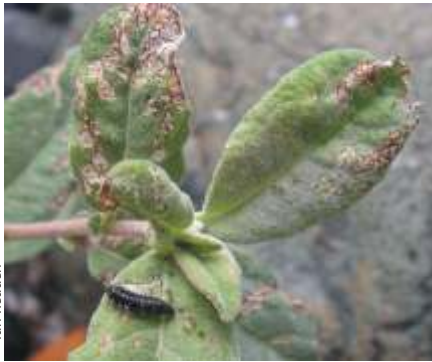
Figure 2. Beetle larvae and damaged willow leaves, June 2005.

monitoring demonstrated that that red-osier dogwood was the preferred browse species as 71% of the growing live stakes were browsed, followed by cottonwood (27%) and willow (3%). The willow may have experienced some mortality, possibly due to an infestation of willow leaf beetle (e.g.,

*Plagiodera versicolora*; Figure 2). These beetles are not known to cause tree mortality; however, in the case of the cut and transplanted stakes, the cumulative stress may have led to some mortality.

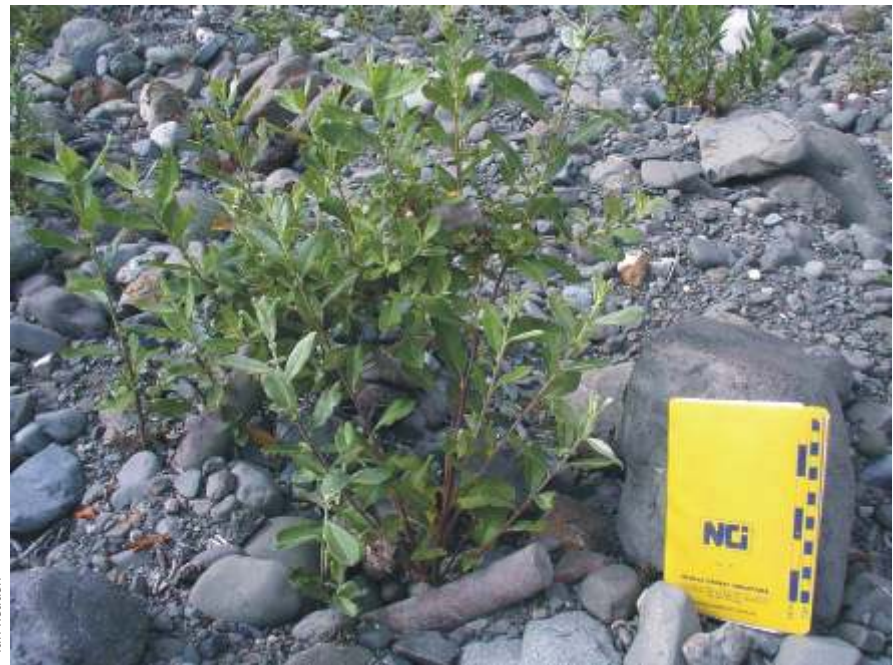
Figure 3. Willow live stake growth, June 29, 2005.

The project measured the number of epicormic branches per stake to further assess live-stake performance. In general, most willow stakes had between 1 and 10 branches, and only 9% had 11 or more branches (Figure 3). Cottonwood stakes had similar results (Table 1). In contrast, nearly all of the red-osier dogwood stakes (96%) had 1 to 5 branches with an approximate mean epicormic branch

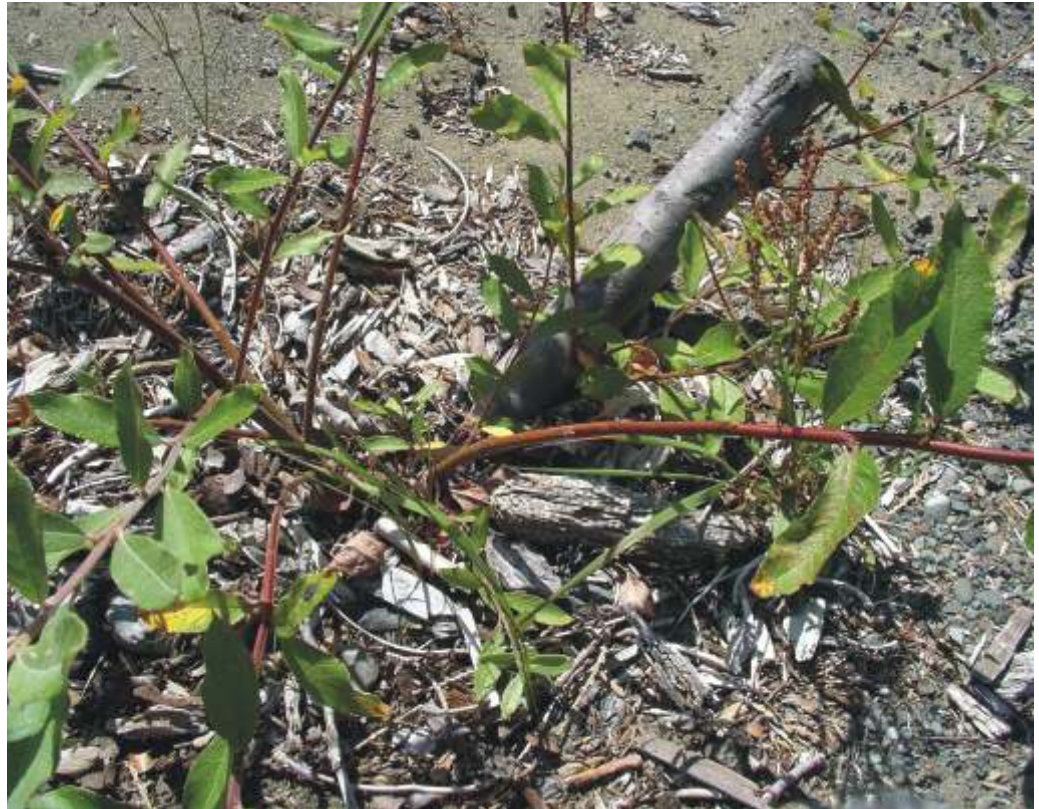
Figure 4. Fine sediment and small organic debris collected around live stake.

Other vegetation measured in the monitoring plots did not show changes in species composition or relative abundance compared with baseline conditions. Changes in bed material composition were generally small, as it appeared that the river had not inundated many of the areas over the winter. Where gravel bars had been inundated during peak flows,

fine sediments and small organic debris had accumulated at the base of stakes as expected (Figure 4).

The results of the first year of monitoring were positive, with a stake survival rate of 90% and indications that, when inundated, the stakes are effectively trapping fines and organics. Over time, this process will allow the successive establishment of riparian vegetation, which in turn is the key to long-term channel stabilization.
