Repair of the Kitseguecla* Forest Service Road: A Blend of Conventional and Bioengineering Methods

Alan Harrison

Introduction

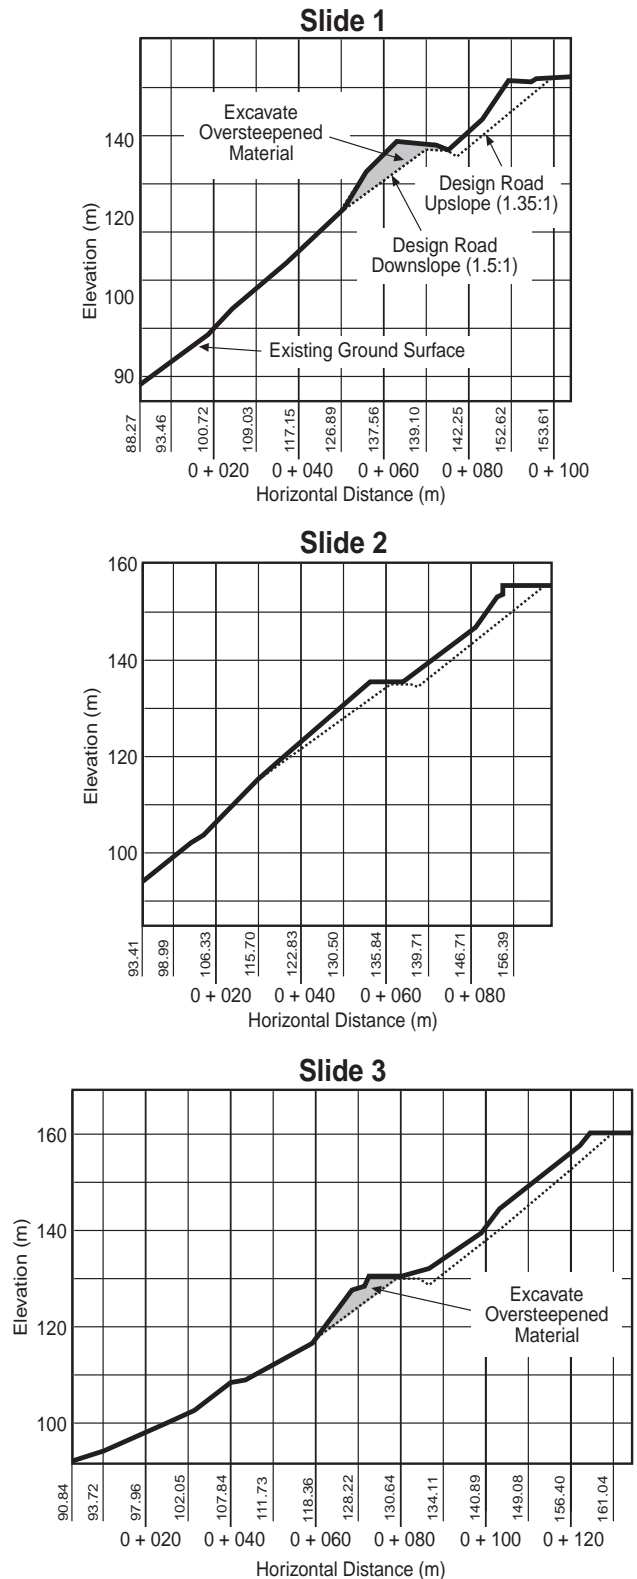
Figure 3. Road construction profiles by Ministry of Forests Regional Office (adapted from Graham 1995)

- Improving the road alignment by moving the road into the hillside and away from the unstable slide scarps, removing the excess road sidecast materials from Slides 1, 2, and 3, and cutting back the oversteepened cut slopes at Slides 1 and 2. This is illustrated in Figure 3.

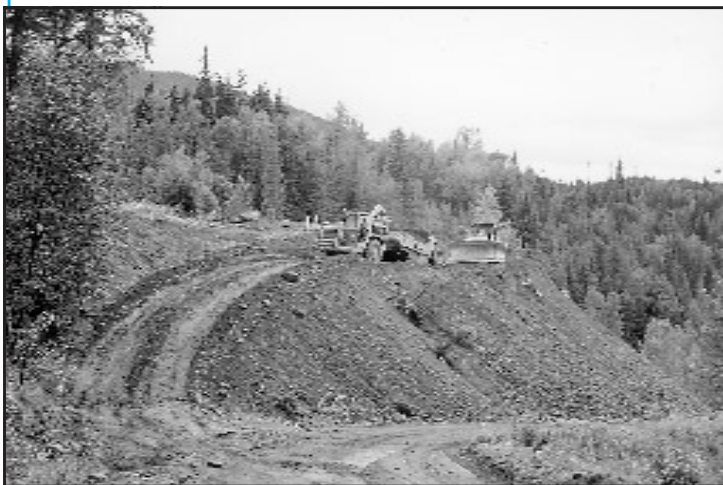
Figure 4. Conventional road stabilization, July 1996.

Approximately 18,600 m³ of material from sidecast and cut slope pullback was removed to the waste area (Figure 4). To construct the river berm and to fill Slide 3 required the quarrying of approximately 4,300 m³ of rock. Access to construct the river berm was by a temporary tote road, which was deactivated on completion of the berm. Figure 5 illustrates the completed berm. Instream construction was coordinated with, and approved by, the Department of Fisheries and Oceans and the Ministry of Environment. During construction, the latter agency found that the 3.5 m wide berm restricted river flow and required that it be pulled back and blended with the natural slope.

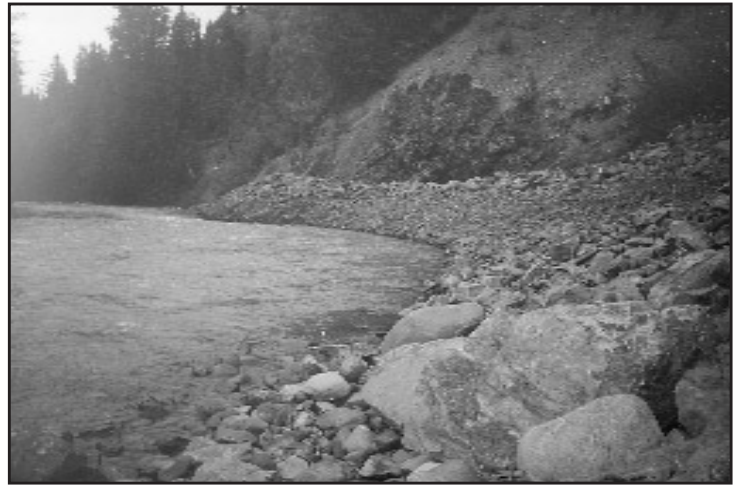
Figure 5. Finished berm constructed instream to prevent undercutting slopes.

- Constructing a rock rip-rap berm (150 m long, 3.5 m wide) along the edge of the river to protect the toe of the slides from erosion. The berm is to provide access for construction and maintenance, and to serve as a runout area to prevent any future slides from flowing directly into the river.

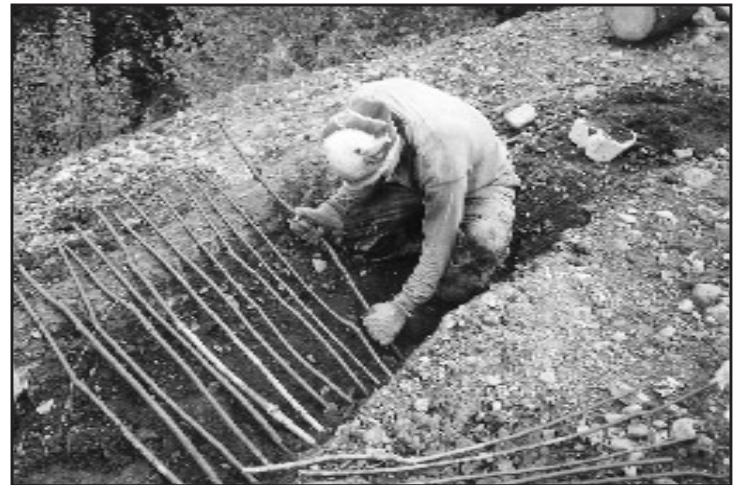
Figure 7. This forest worker is placing de-leafed, soaked, and sprouted cuttings in a modified brush layer (from Rabnett 1997).

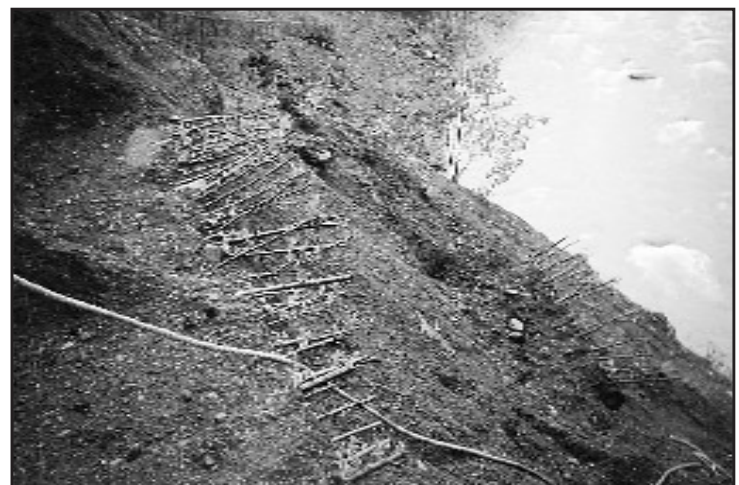
Figure 8. Three days of soaking ensures the success of sprouting. Root development is controlled by the soaking period, and is limited by the installation technique and site conditions (from Rabnett 1997).

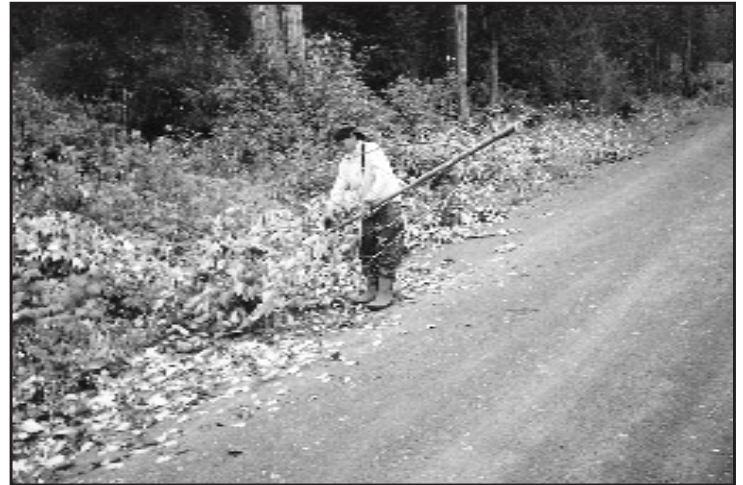
Figure 10. Forest worker preparing cuttings for live pole drain construction (from Rabnett 1997)

drain installation is illustrated in Figure 9. The pole drains consist of bundles of living cuttings, which are placed in shallow trenches to intersect, collect and conduct excess soil moisture away from unstable areas. The live pole drains grow into a dense stand of hydrophilic vegetation, which promotes site de-watering through the process of plant transpiration. The drain locations are shown on Figure 2. Figure 10 shows a worker preparing material for use in the drain.
