# The San Juan Watershed Agreement

*Bud Iverson and Deb Epps*

## Introduction

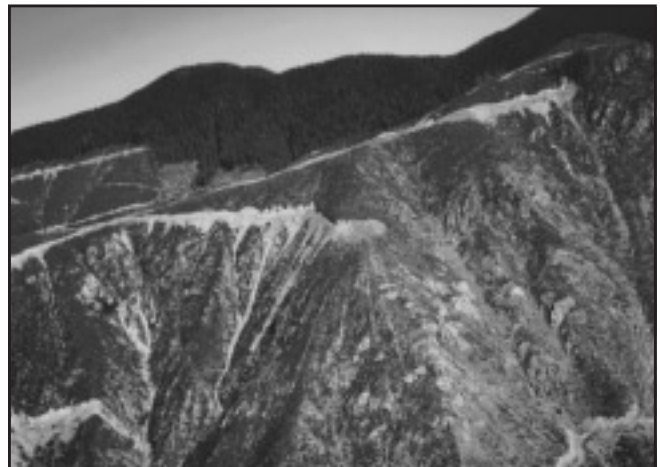
Figure 4. An example of some of the areas chosen for road deactivation.

During 1997/98, a program including detailed assessments and prescriptions, hillside restoration and road deactivation was carried out (Figure 4).

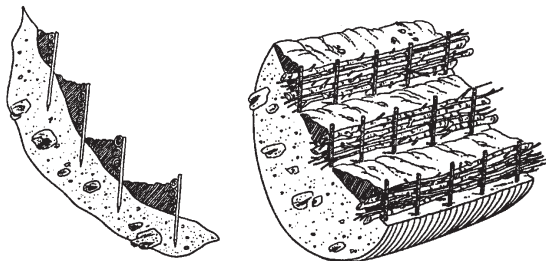
Figure 5. Wattle fences are used to allow oversteepened slopes to support plant growth. The section shows the effects of steeper slopes on wattle fence spacing (after: Polster, 1997).

**Wattle Fences:** Wattle fences (Figure 5) are short retaining walls built of living cuttings. These walls take up the vertical component of the slope, reducing the effective slope angle and allowing vegetation to become established. In addition, the living cuttings used to make the walls sprout and grow, thus further strengthening the structure. Wattle fences are used where site moisture conditions will allow the living cuttings on the face of the fence to sprout and grow. Sites where fine textured soils can provide ample summer moisture or where seepage of groundwater provides moisture are suitable for wattle fence installations.

Wattle fences are constructed by establishing the supporting rebar or cuttings in a row in the ground and placing the cuttings behind these supports. Soil materials are then backfilled behind the cuttings and additional cuttings are added to increase the height of the fence. Resloping behind the fence should be conducted to create a slope of about 2 : 1 or less between the top of the fence and the bottom of the fence above. Wattle fences are constructed from the bottom of the slope up the slope so that workers may have a place to stand while additional fences are constructed.

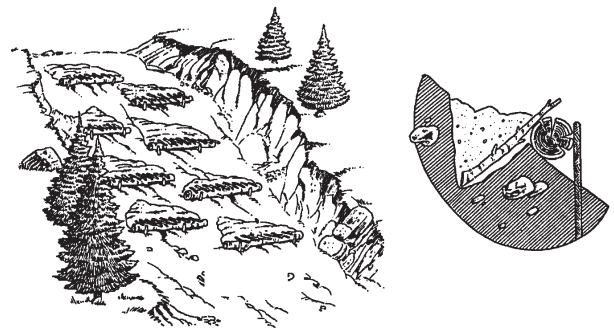
Figure 6. Modified brush layers can be built with either a log or a board for support. They should be staggered across a slope so that material rolling down the slope does not have a chance to accelerate before it is caught. The section shows the normal backfill which creates a small bench (after: Polster, 1997).

Modified brush layers (Figures 6 and 7) are supported on a short, small log or board. The use of a log for support of the brush layer provides the advantage of a small terrace which can serve to “catch” rolling rocks rather than allowing them to roll down the slope, gathering speed and damaging vegetation or entering stream channels. Although the log will eventually rot, the cuttings will, by that time, have grown to the point where they are stabilizing the slope. As the cuttings that are used in the brush layer grow, the wall of plants will also serve to trap rocks and soil and prevent movement of materials down the slope, thus further protecting vegetation on the slopes. Modified brush layers can be used on sites that would be too dry for effective wattle fence growth but where some form of additional support is needed for stabilization of the slopes.

Reinforcing steel bar (rebar) is used to hold the modified brush layers in place. One hundred and twenty centimeter (120 cm) long rebar has been found to be best for support of the modified brush layers. The modified brush layers are constructed by initially establishing the rebar in the ground. The log or board is then placed above the rebar on the slope, and partially back filling behind the log or board creates an initial bench. The cuttings are then placed on the bench and 30 cm backfill is pulled down to cover the cuttings. The cuttings should protrude past the edge of the log or board about 5 cm. Like wattle fences, modified brush layers should be built from the bottom of the slopes to the tops thus providing places for the workers to stand as they construct additional structures. Modified brush layers can be very useful in the control of raveling from a road cut slope. The bench created initially serves to trap rolling materials while the growth of the cuttings eventually forms a wall of living plant materials. Modified brush layers can also be effective in the stabilization of sliver fills and raveling fill slopes (Polster, 1997).

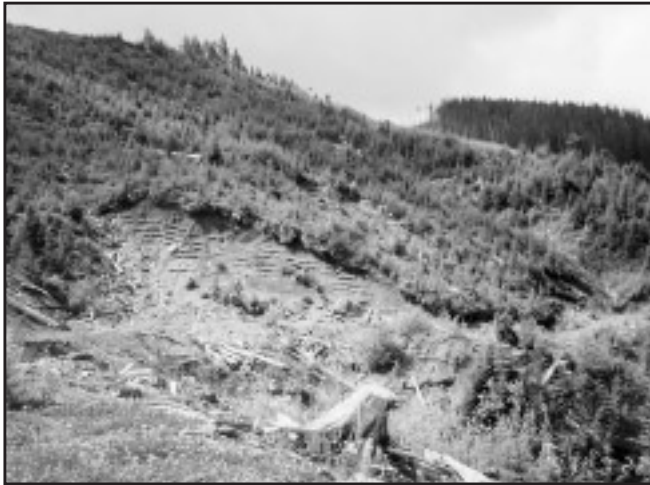
Figure 7. Modified brush layers used to stabilize the slope.

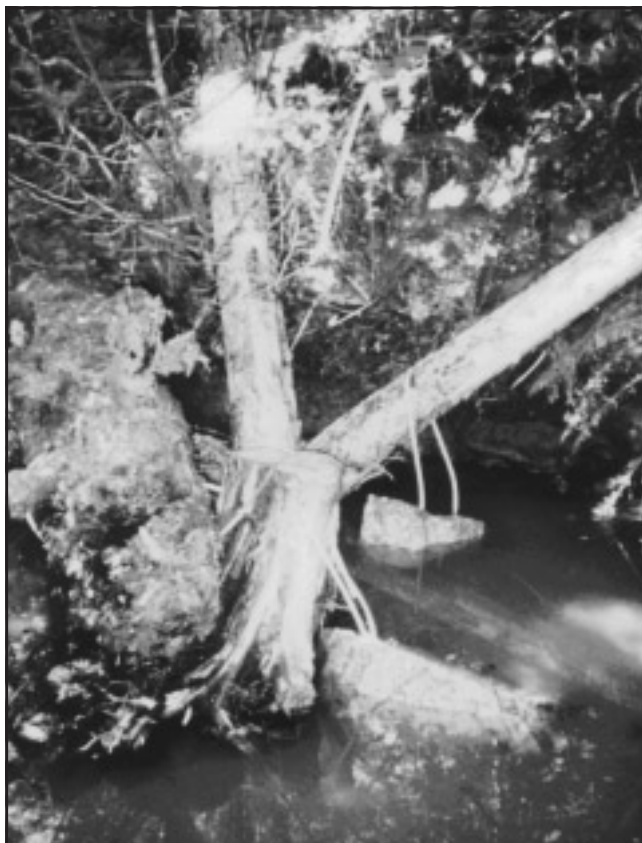
Figure 11. Typical installation in 5 Mile Creek.

At Five Mile Creek, all structures tested were given a class 4 biological ranking (Figure 11). Although the geomorphic ranking was not as high, the reach was said to provide good LWD cover and a good ratio of pools to riffles. This creek had the highest catch per unit effort of the Vancouver Island Watersheds monitored. Coho salmon accounted for 214 (96%) of the 223 fish sampled.
