## Contents

### Integrated Watershed Projects

## INTEGRATED WATERSHED PROJECTS

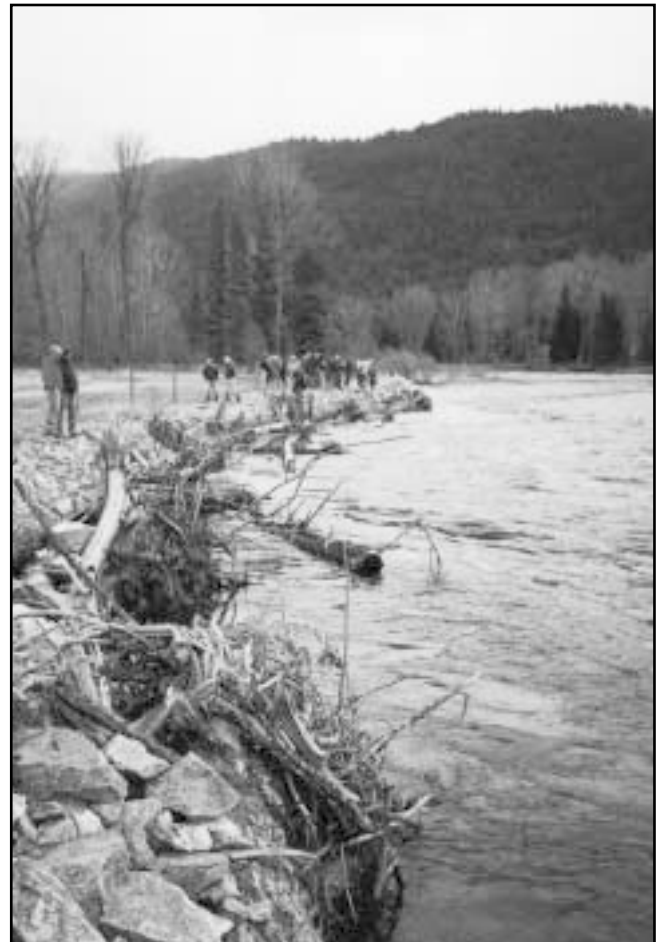
Participants at the BC - US Technical Exchange visiting a recent rip-rap and LWD treatment of an eroding bank at the West Kettle River near Beaverdell. (Work completed by Attrill Woodworking Services.)
