Technical Tip

Channel Rehabilitation: Debris Groins as a Bank Stabilization Option

Rheal Finnigan and Pat Slaney

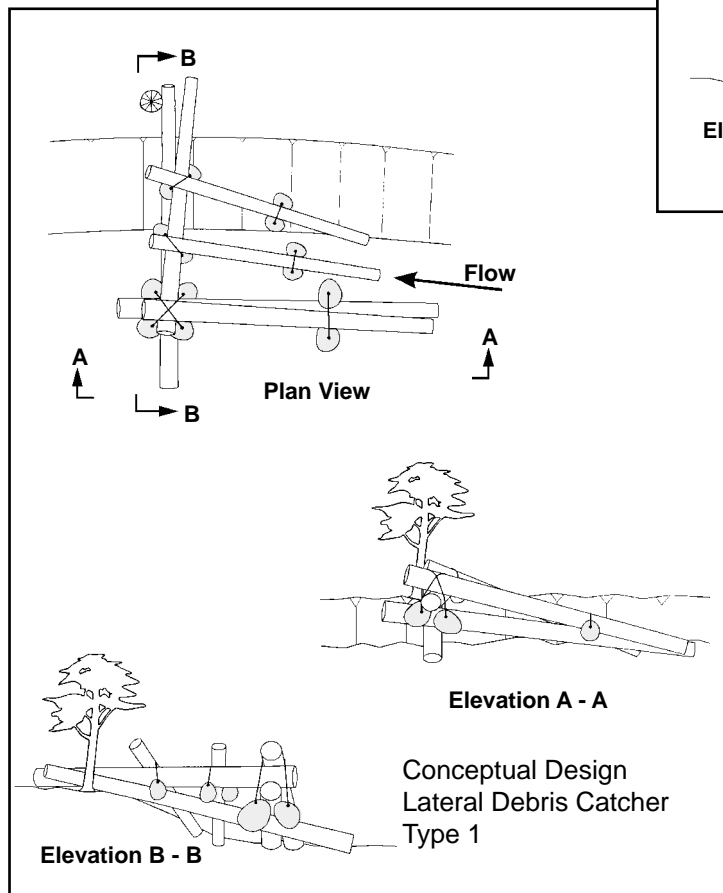
Figure 2. Debris groin type 1 for sites where there are no boulders in the channel to attach logs (Boulders are slung over logs using expoxied solid core 1/2" galvanized cable).

Figures 2, 3 and 4 show the design features of debris groins. Specifications for materials will vary with stream power, as indicated by channel width and gradient. The width of the debris groin should be adjusted according to the amount the channel has been widened. At Narrowlake Creek, where the stream was widened by 2-3 times, the debris groins were 6 m wide. Structures installed for demonstration in the more constricted channel at Keogh River were only 3 m wide. Height is another important design feature. Debris groins should extend just above bankfull flood levels to prevent trapped woody debris from being washed away at a peak event, as occurred at the Coquitlam River (Figure 5). Some variations in design will also be needed to take advantage of large instream boulders for attachment, or to provide an elevated support for the structural members of the debris groins if the site is along a steep bank. Use of opposing rootwads to provide in-channel height is an option that also creates prime rearing habitat

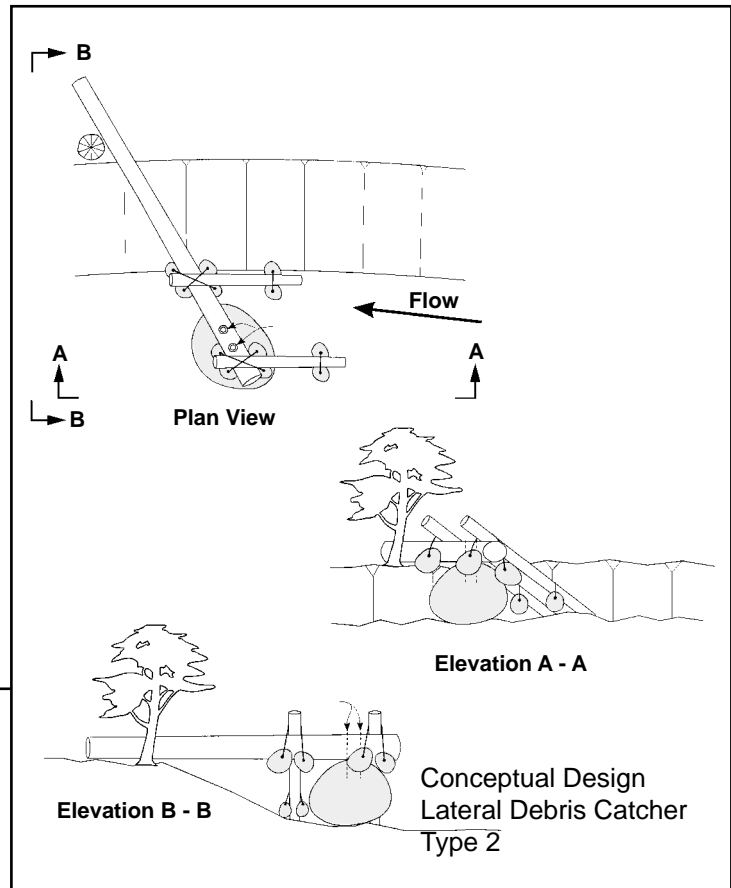
Figure 3. Debris groin type 2 for sites where a large boulder is available in the channel for epoxy cable attachments (Boulders are slung over logs using expoxied solid core).
