Live Gravel Bar Staking Channel Stabilization in the Lower Elk River

Iain D. Cuthbert and Ian D. Redden

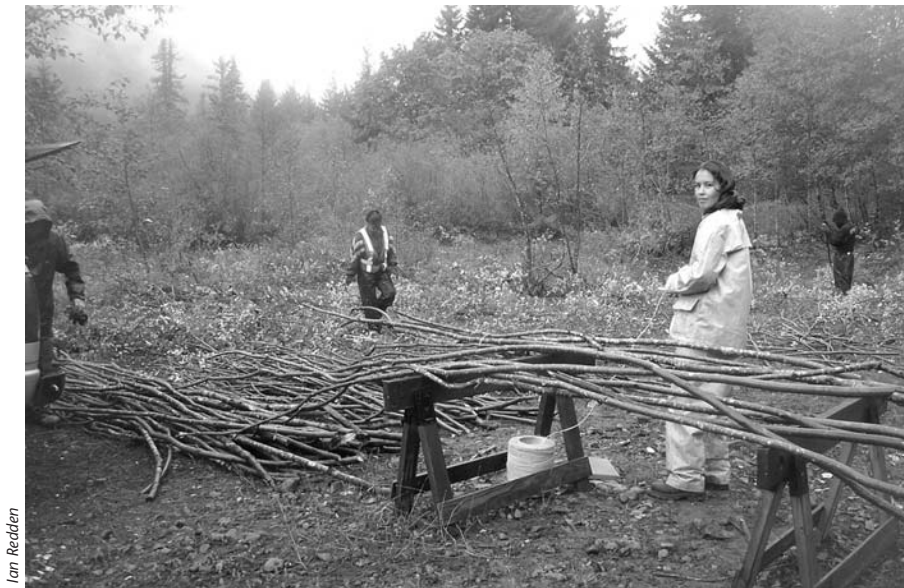
Figure 2. Assembling limbed poles into bundles.

collected, topped, and limbed the cut trees. Using high quality, relatively expensive pruning and lopping shears was invaluable, as smaller shears tended to break, disrupting production. The topped and limbed "poles," which ranged from 2 to 4 m in length, were then placed on sawhorses and tied with biodegradable sisal baling twine into bundles of 7–10 stems (Figure 2). Flagging tape was attached to each bundle, with a different colour used for each day. When the weather conditions were cool and wet, bundles were loaded into trucks and taken to the soaking site at the end of each day. During warmer, sunny weather, bundles were taken to the soaking sites throughout the day to prevent desiccation (wilting) and death. The use of a Silva cool-tarp to cover the bundles during collection would have been beneficial during hot, dry weather. Production averaged 2840 stakes per day for a seven-person crew.

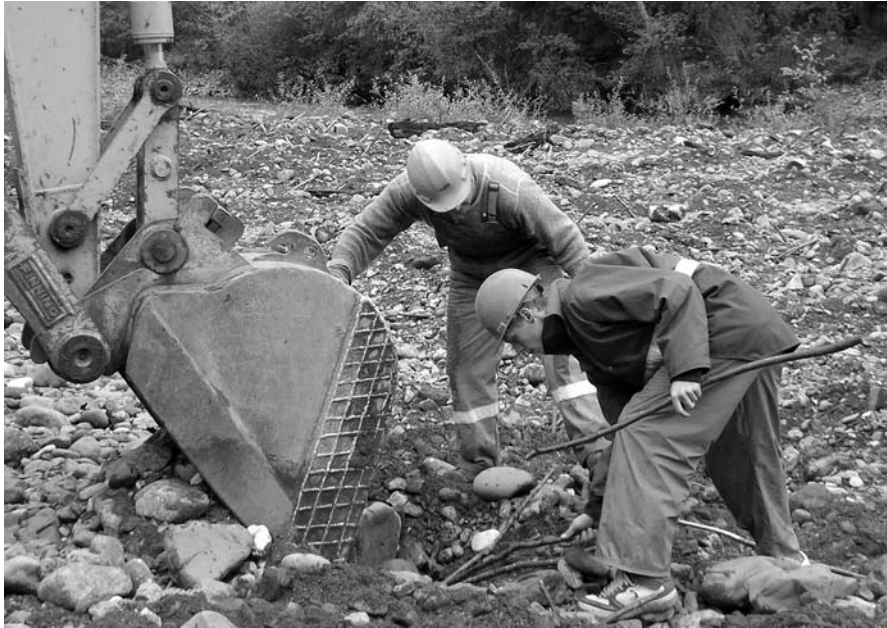
Figure 3. Crew member instructing student on planting stakes.

hand (Figure 3). The excavator then withdrew its bucket allowing the gravel to settle back in place. The stakes were planted with about three-quarters of their length in the gravel at a 45° or greater downstream angle (Figure 4). Four large stakes and three to five undersized stakes, if available, were placed into each opening, taking about one minute for each opening. While the undersized stakes may not flourish as well as the large stakes, they significantly increased the overall number of stakes planted, which should improve the chances of the project in overcoming mortality due to elk browse.

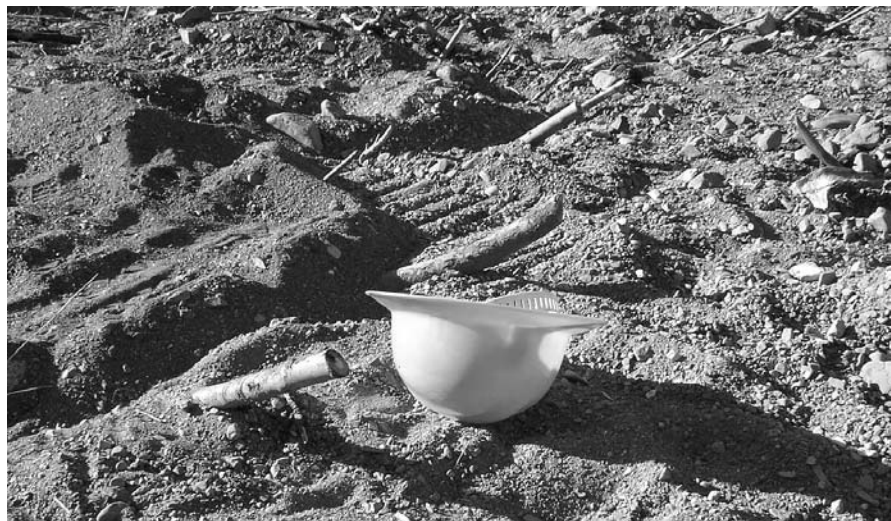
Figure 4. Planted stakes.
