Re-creating Meandering Streams in the Central Oregon Coast Range, USA

Barbara Ellis-Sugai and Johan Hogervorst

This article describes the methods and lessons learned in re-creating two stream channels on the Central Oregon Coast Range.

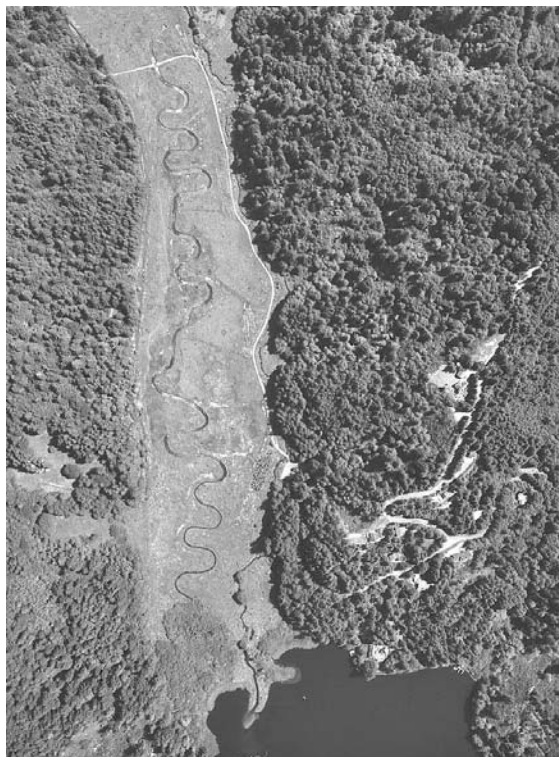
Figure 1. Low-elevation aerial photograph of the new Bailey Creek channel before connection to the old ditch, September 2000.

The new 1692 m (5500 ft.) long channel was excavated in late summer 1999 (Figure 1). The outside bends of meanders were revegetated with willow stakes in early spring 2000, and the new channel was connected to the ditch in October 2000. The abandoned ditch

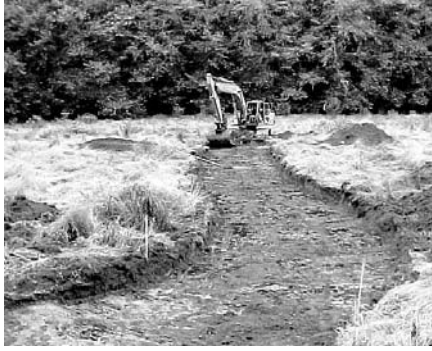
Figure 3. Construction of the new Karnowsky Creek channel, summer 2002. Stakes in foreground identify the location of a transition from a riffle to a pool. Note the excavated mounds of soil left on the floodplain.

The new Karnowsky stream channel was built in late summer 2002 (Figure 3). In the lower part of the valley, where wet soil conditions persist throughout the year, the excavated material was piled in mounds and shaped on the valley floor. This method reduced both haul costs and potential for soil compaction from dump truck traffic. Mounds also offered high points in the floodplain that provided good planting sites for Sitka spruce and western redcedar. During the first winter after construction, willow stakes were planted in the banks, and trees and shrubs in the floodplain. At that time, water was not flowing in the main channel, which gave the willows a chance to establish.

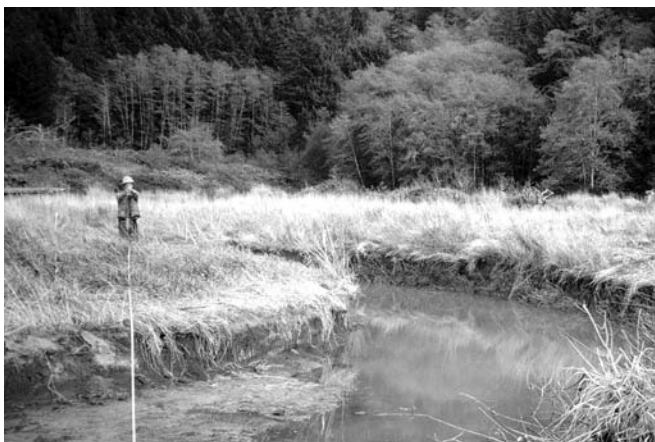
Figure 4a. New Bailey Creek channel at photo point 7, summer 1999.

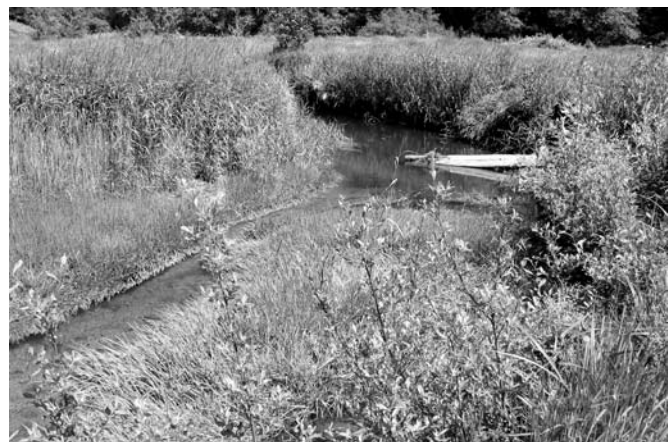
Figure 4b. New Bailey Creek channel at photo point 7, summer 2003.

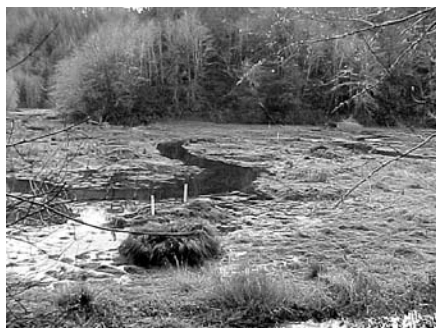
Figure 5. The new Karnowsky Creek channel in the lower valley during high winter flows. Conifer seedlings in plastic tubes are planted on the mounds left on the floodplain.
