B.C.'s Watershed Restoration Technical Bulletin

Vol. 2 No. 3

Lateral and Mid-Channel Bar Stabilization

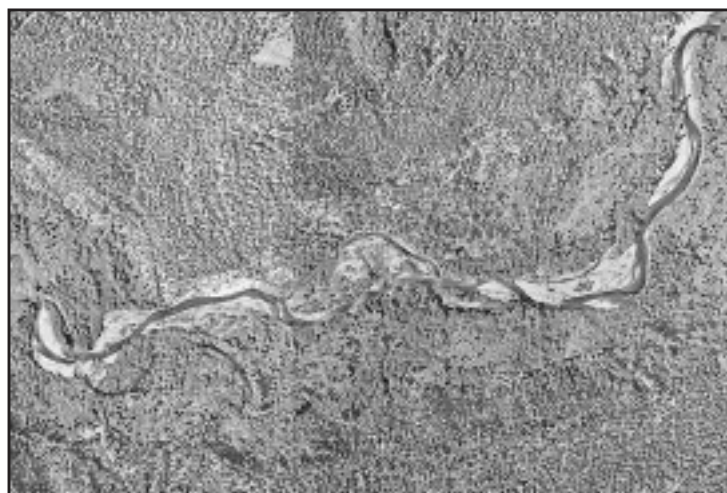
Figure 2. Aerial photo of treatment reach 3 of Narrow Lake Creek shows greatly widened banks and expansive areas of sand and cobble bars (taken in 1996).

Historically, large conifers grew along the streambanks and provided bank stability particularly at high flows, with their deep roots. With their removal, and with the building of roads and skid trails for forest harvesting activities during the 1960's, bank stability has been greatly reduced and sedimentation rates increased (a process described by Kellerhals and Miles 1996). Specifically, the sources of sediments include: upslope landslides in the headwaters, poorly constructed and undersized road crossings, and steep slopes and streambanks into which the stream is now cutting. Combined with the characteristics of the region described above, the result has been an extreme widening of the channel (up to 50 m bankfull width in some areas, Figure 2). One of the reaches in particular (Treatment Reach 3) is now composed of multiple,

threaded, shallow streams; and large buildups of aggraded sediments forming bars, mostly of cobbles (Figure 2).

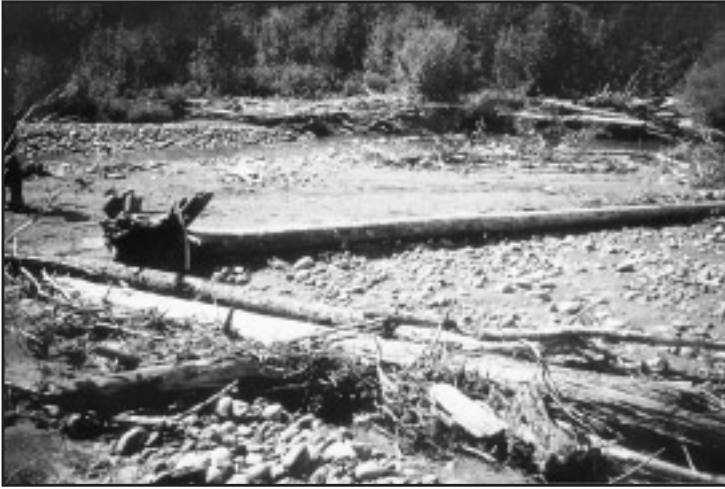
Figure 3. A typical V-shaped arrangement of large woody debris (LWD) has been deposited on a bar. Natural arrangements of LWD provide a template for structures which accelerate bar stabilization.

shaped and other arrangements of large wood are deposited naturally on the bars (Figure 3). Single logs generally end up with their root wads facing upstream (Figure 4). These structures then serve to trap other woody debris of variable size by reducing local water velocities (Figure 5). This accumulating material acts to shunt water away from the bars permitting further accumulation of both woody debris and sediments. Fine sediments tend to settle out below the structure where water velocity slows. Small plants and shrubs including willows take root in the accumulated fines, and in time these bars are able to support larger trees such as alder, adding additional root strength (Figure 6). A similar process of re-establishment of mid-channel bars can be seen in Trapping Creek (Southern Interior), the Squamish River (Lower Mainland), and Glacier Creek (Kitzumkalum System).

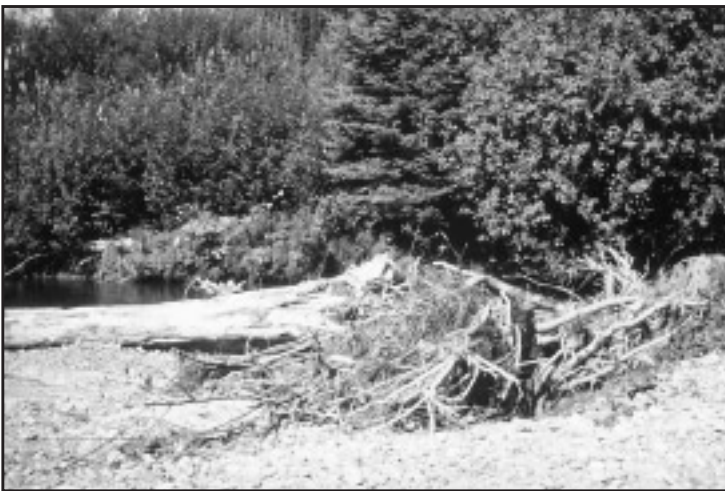
Figure 4. Single logs generally end up with their root wads facing upstream.

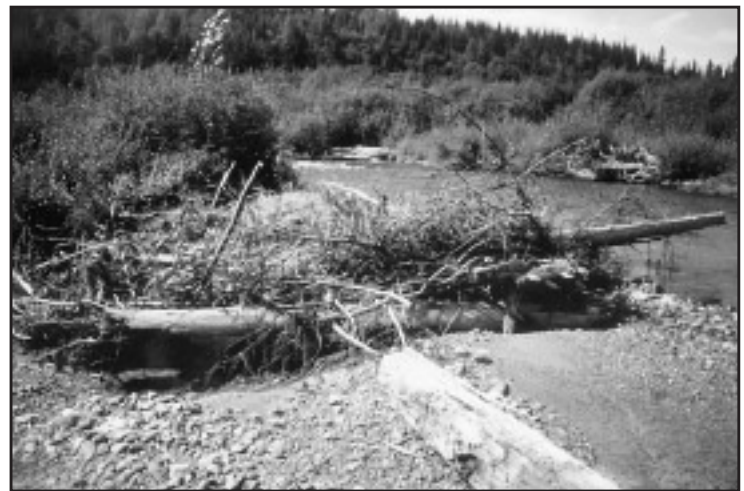
Figure 5. The root wad portion of the log is especially efficient at trapping other woody debris of variable size (the log shown is the same as in Figure 4).

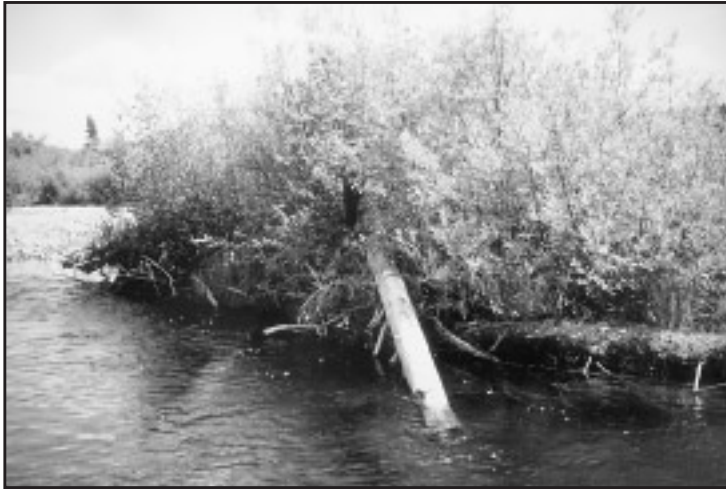
Figure 6. Small plants and shrubs including willows take root in the accumulated fine sediments.
