Stream Restoration and Slope Stabilization of a Ravine Landslide

B. Sander, J. Summers, M. Bradshaw, and T. Watson

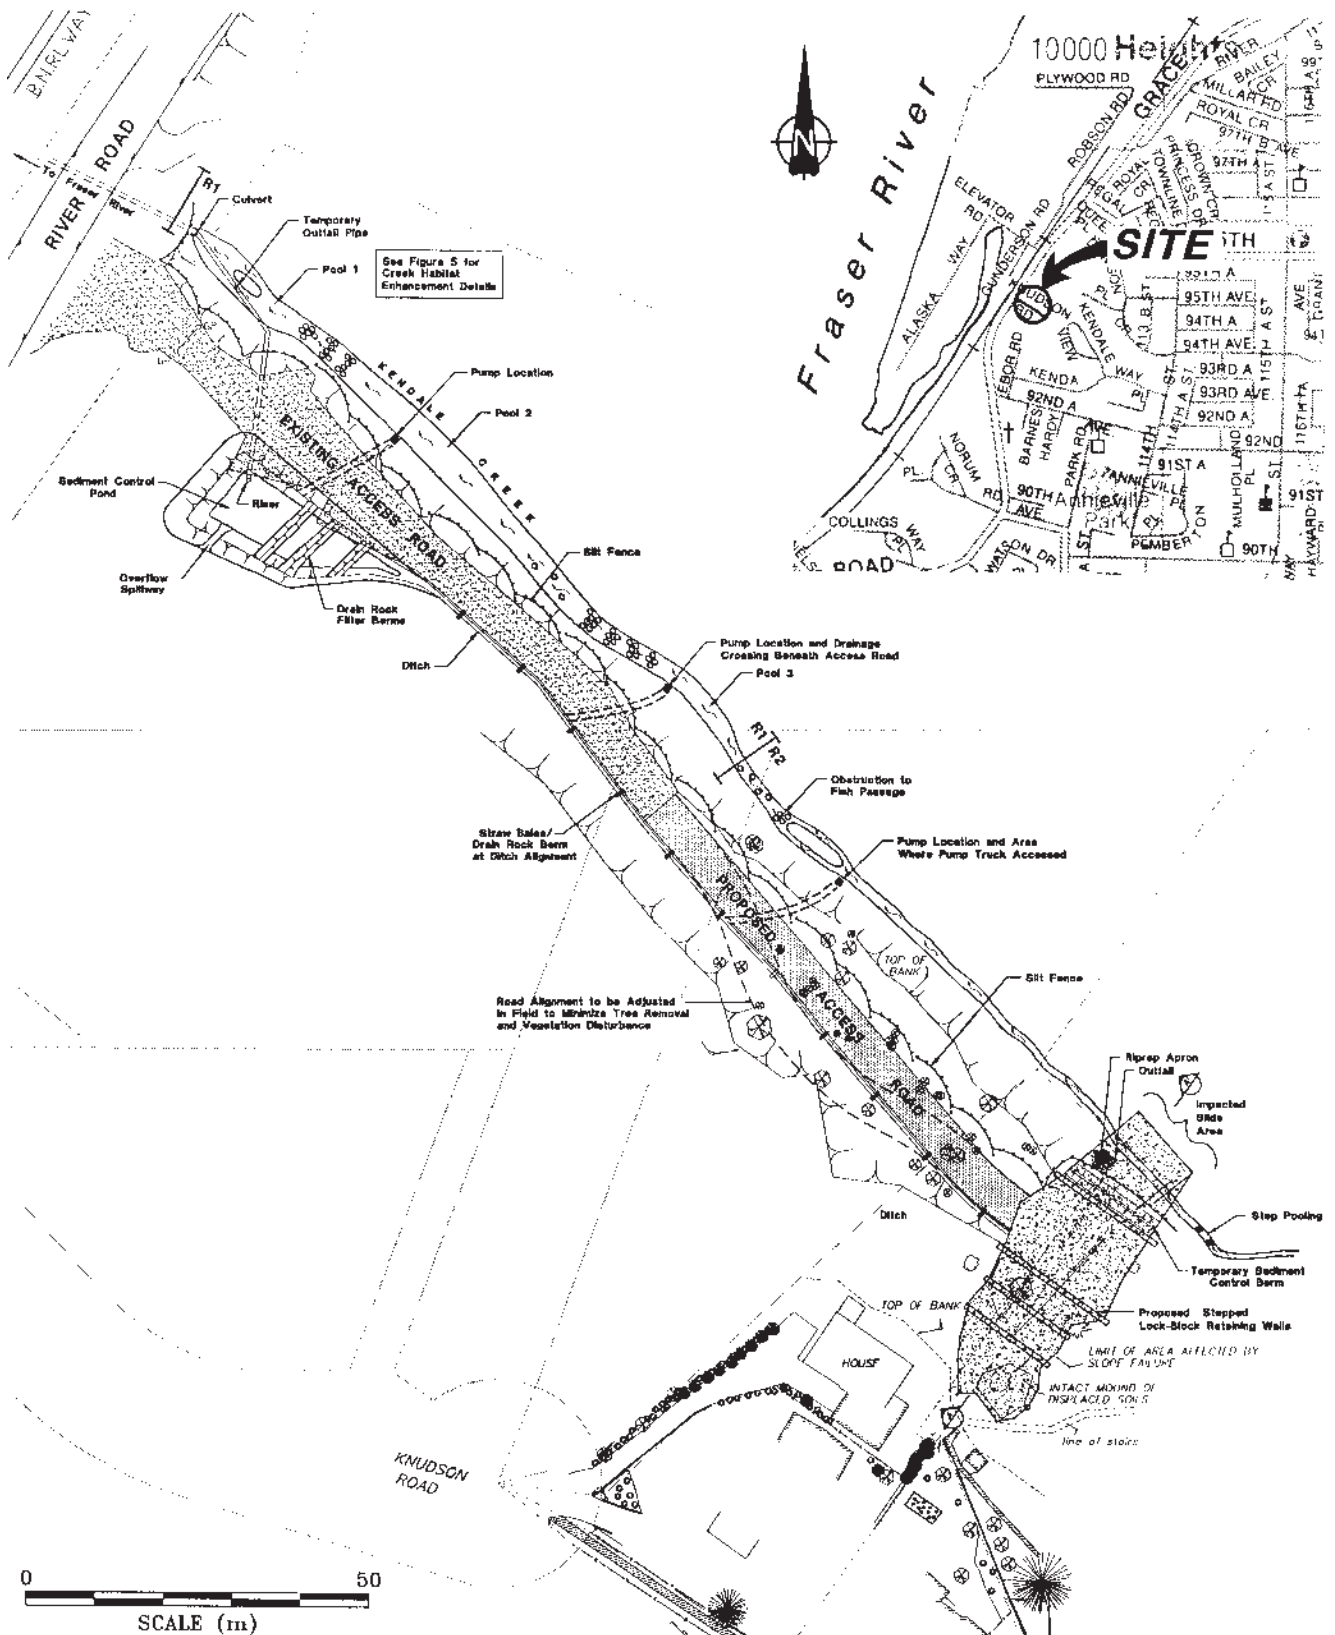
The obstruction occurred between the two reaches, located about 100 m upstream from River Road (Figure 1). The obstruction was about 1.5 m in height and was the inferred limit of upstream fish movements, given that no fish were captured or observed above this point. The creek width upstream of the obstruction ranged from 1 to 3 m. Both banks were densely vegetated with shrubs, ferns and deciduous trees (broadleaf maple and red alder). Stream gradients were less than 5%. Reach 2 continues to the bank failure zone approximately 100 m upstream of the obstruction. The creek displays similar characteristics above the failure zone, but limited surveys were undertaken above this zone and the extent to which

Figure 1. Location and plan of slope failure, access road and characteristics of Kendale Creek in North Delta before site rehabilitation.

The slope failure caused deposition of a large amount of sediment in a 12 m wide zone in the creek channel adjacent to the failure zone (see Figure 1). When these deposited materials were mobilized at higher flows, they damaged habitat downstream by reducing water quality and depositing in pool habitat. It was also observed that the channel was relatively narrow

The site plan (Figure 1) shows the location of the sediment control pond as well as pumps and their respective discharge lines. As work proceeded, it became clear that suspended solids could not be effectively controlled by instream placements of hay bails or silt fencing. Attempts to filter sediment-laden water by placing berms of clean crushed gravel instream were moderately effective, but not to the extent necessary for the protection of fish and habitat. Consequently, high volume portable pumps were used to divert sediment-laden water from instream activities to the ditch line along the temporary access road, and ultimately to the sediment control pond. This proved
