How Practical are Precipitation Shutdown Guidelines?

Paul Marquis

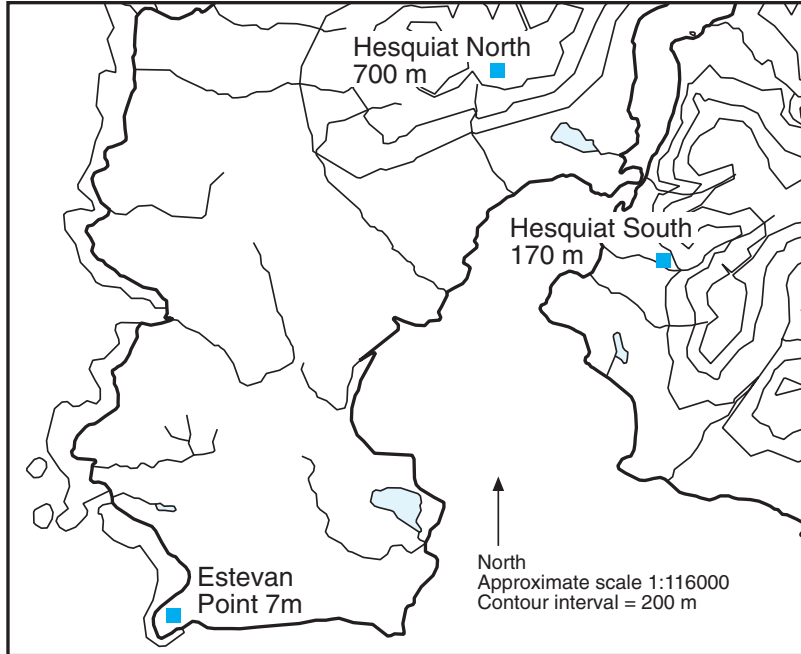
Figure 2. The Hesquiatic Basin is located approximately 50 km northwest of Tofino on Vancouver Island.

An example of how the factors of elevation and aspect affect precipitation totals is illustrated by examining three meteorological stations located in the Hesquiat Basin area of the west coast of Vancouver Island (see map, Figure 2). The Estevan Point station, operated by Environment Canada, has an elevation of 7 m. The Hesquiat South installation is situated about 14.5 km northeast of the Estevan Point station at an elevation of 170 m and the Hesquiat North site is approximately 15.1 km north of Estevan Point at an elevation of 700 m.

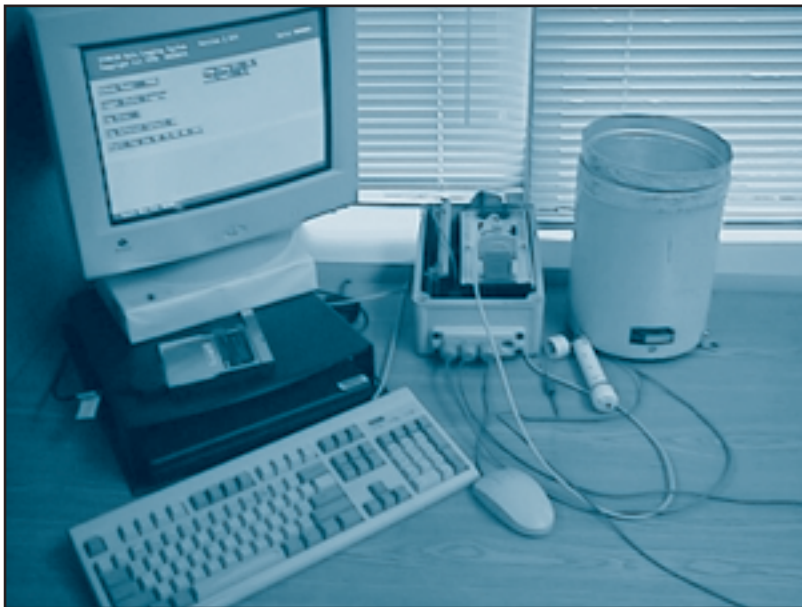
Figure 3. This is a photo of the equipment installed at the two Ministry of Forests sites in the Hesquiatic Basin. To ensure the accuracy of the data, the installations are periodically replaced with spare units and brought back to the office where the sensors are calibrated.

Both of the Hesquiat sites were established by the Ministry of Forests and consist of a rain gauge and a temperature sensor attached to a datalogger (Figure 3). The distance between these two stations is approximately 5.9 km.
