Abstracts from the US – BC Technical Exchange 2001 in Port Hardy, B.C.

For the past five years a number of watershed restoration specialists and planners from B.C., Washington, and Oregon have come together on an annual basis to share technical information. This year, the meeting was in Port Hardy B.C. and involved one day of presentations and panel discussions and two days of field trips to Keogh River, Mahatta River or Nimpkish River. A wonderful banquet and field trip to the Mahatta River were generously supported by Western Forest Products.

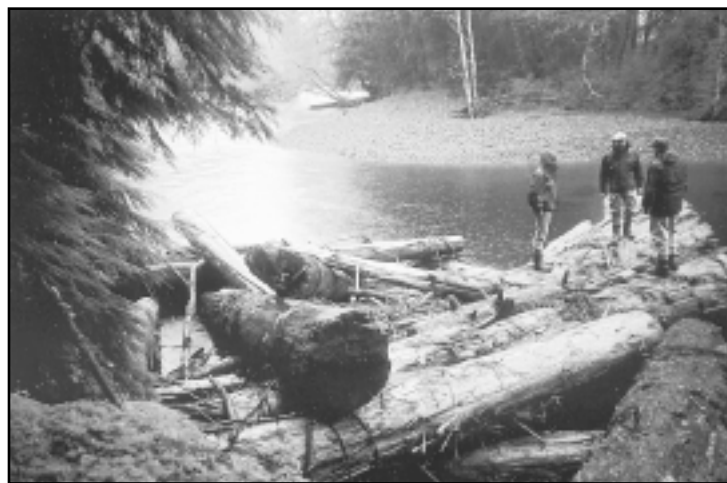
Inspecting a LWD structure on the Mahatta River.

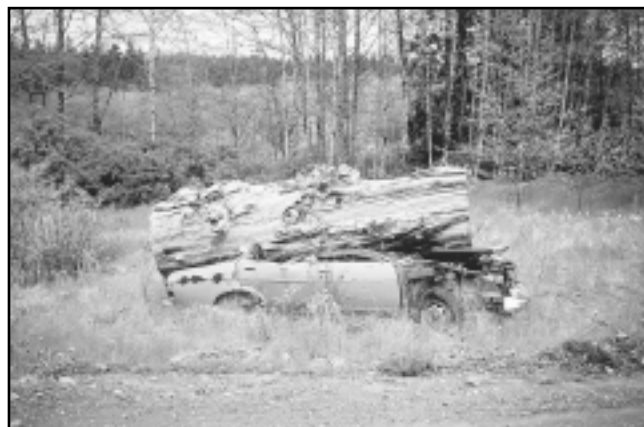
A creative use of LWD and ballast.
